**Subject: Leak inspection  
Beach House Condominiums  
Pass-A-Grille, Florida**

***Leak Inspection Report  
Beach House Condominiums  
Pass-A-Grille, Florida***

# **Beach House Leak Inspection**

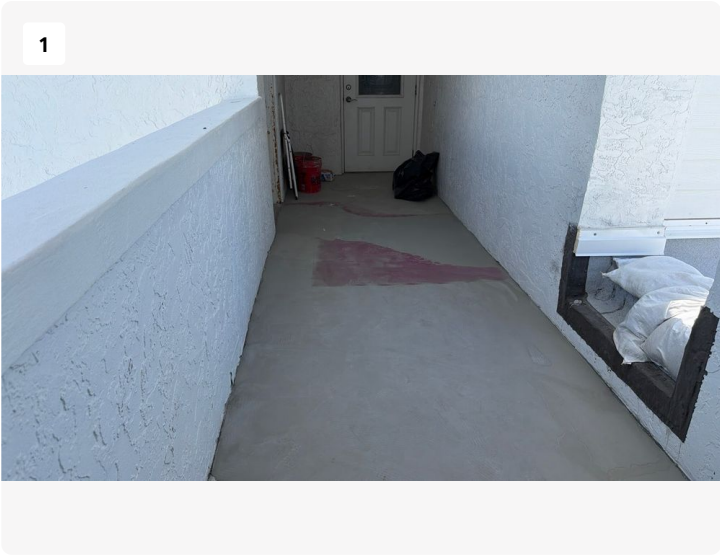
- b. The staining in the kitchen appeared to be due to an unsealed walkway on the 7<sup>th</sup> level that was immediately adjacent to this portion of the ceiling.

The 7th level walkways are currently stripped with portions having sloping material present. No waterproofing or caulking is present.

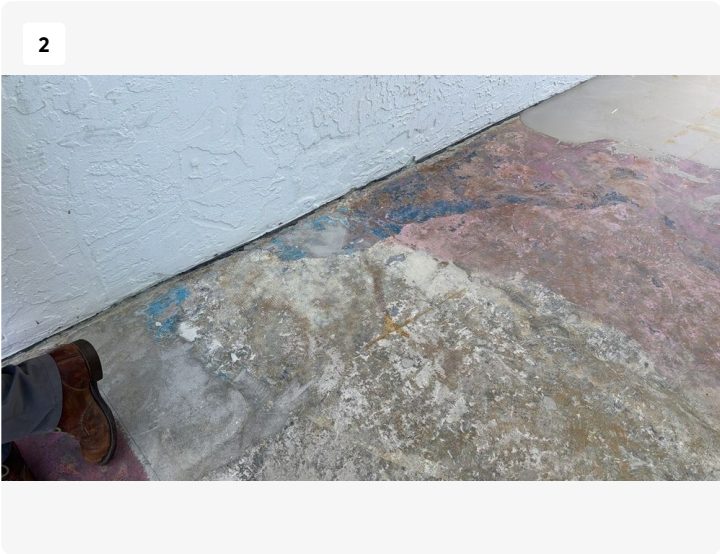
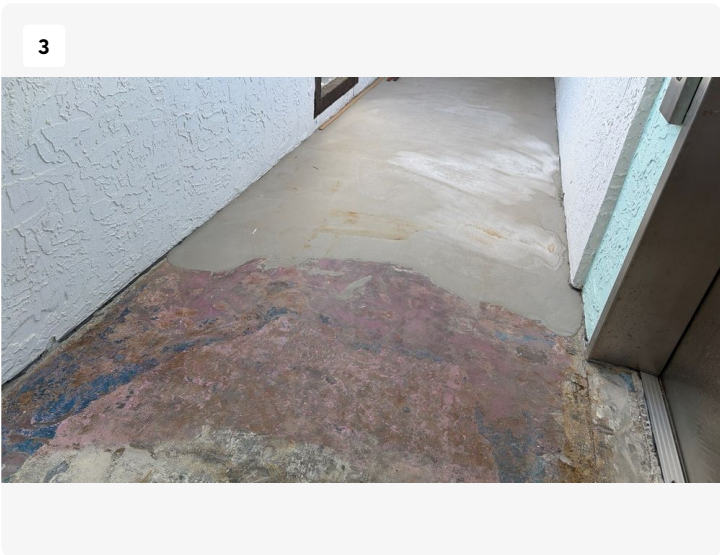
Areas without sloping material present were observed to still have significant amount of residue present and it appeared that the sloping material had been applied over a primer that was applied directly over the residue. Building representative was informed that all of the residue on the flooring should be removed prior to the installation of any sloping or waterproofing material.

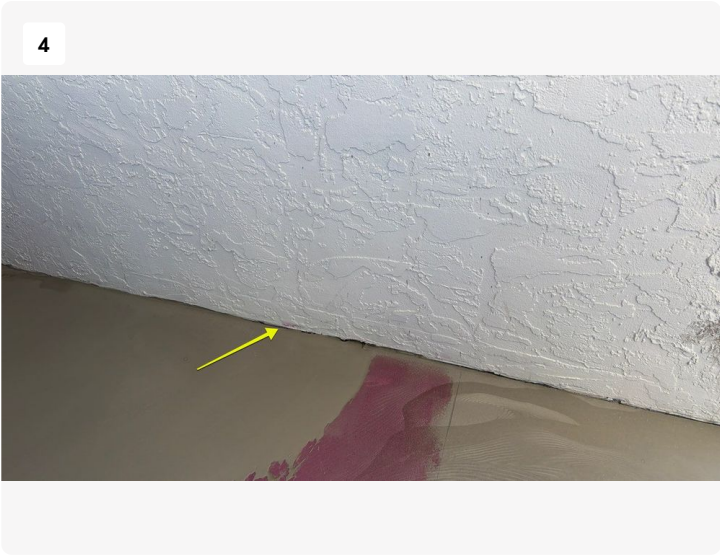
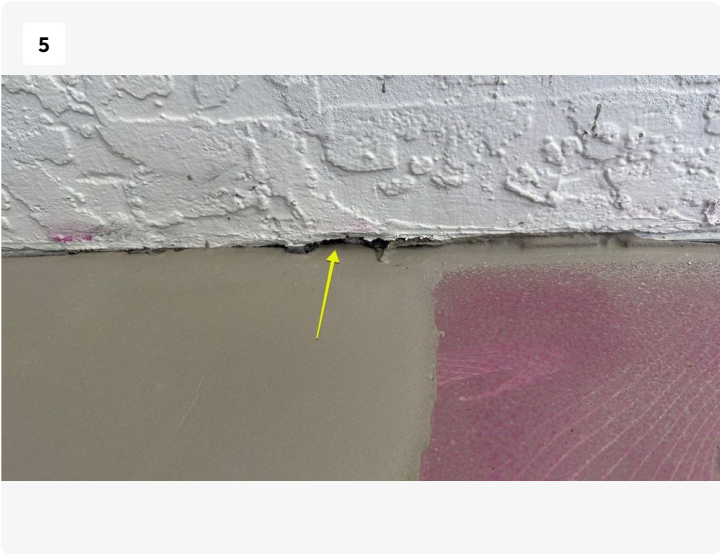
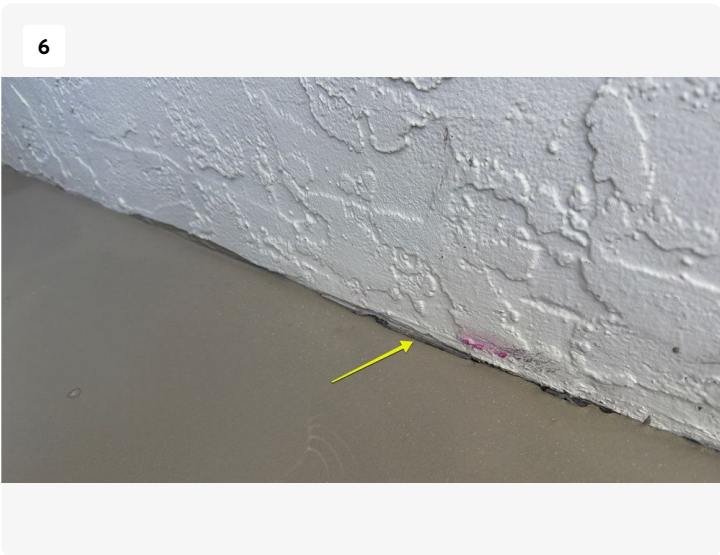
Based on the conditions observed, the leaks in 602 kitchen appear to be caused by an unsealed walkway on the east side of 7<sup>th</sup> walkway. The leaks in the remainder of 602 appear to be caused by an improperly installed and sealed sliding glass door assembly and an unsealed balcony deck on Unit 701. Additionally, the remaining doors on the balconies on Unit 701 were observed to have been improperly installed and unsealed which will further allow moisture to enter the unit and ultimately 602. The leak in 603 appeared to be caused by an improperly terminated/capped drain line. The timing of that work is unknown.

Areas directly adjacent to 701, and directly above the kitchen area of 602 were observed to not have any caulking or waterproofing present on the walkway.

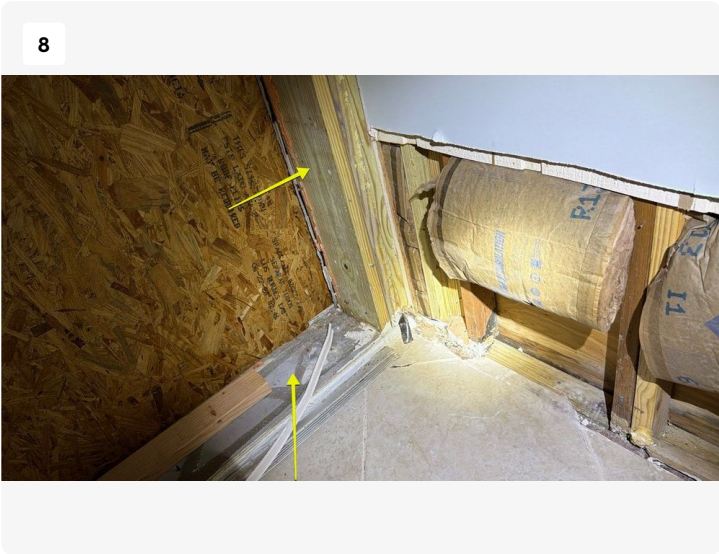
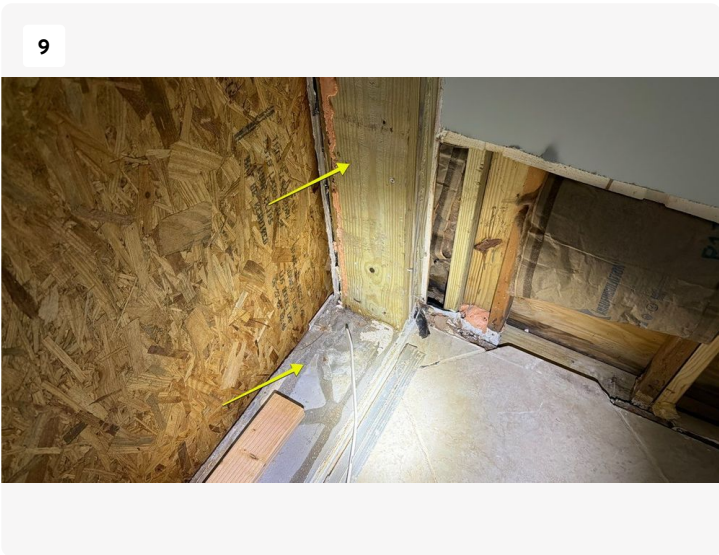
- b. The finish on the owner side of the partition wall had been completely removed. No staining was observed on the wall.
  - c. The interior of the unit was observed to have floor tiles installed on top of decking and sleepers creating a cavity of approximately 2" under the floor tiles.

The floor in the north side of Unit 701 was observed to be floor tile that had been installed on top of sheathing and sleepers resulting in an elevated floor with a gap of approximately 2" underneath. This configuration can allow water to migrate under the floor finish without being observed on the inside of the unit. Additionally, the sliding glass door on north balcony of the unit was removed and observed to have had no flashing or waterproofing installed on the rough opening.

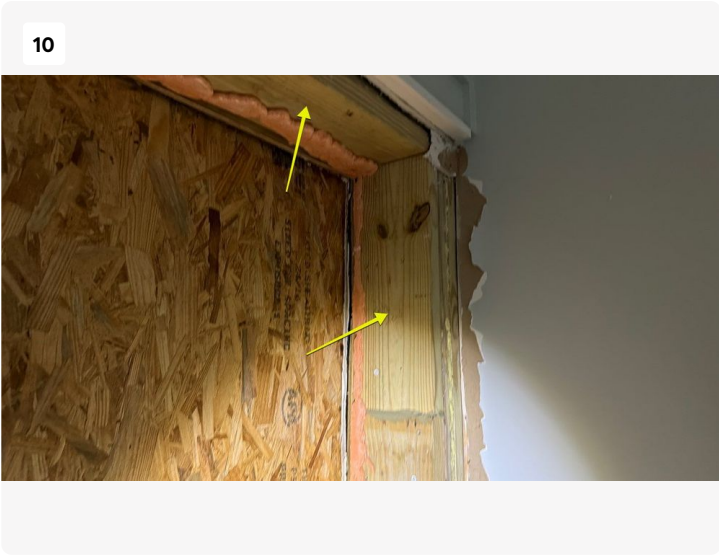
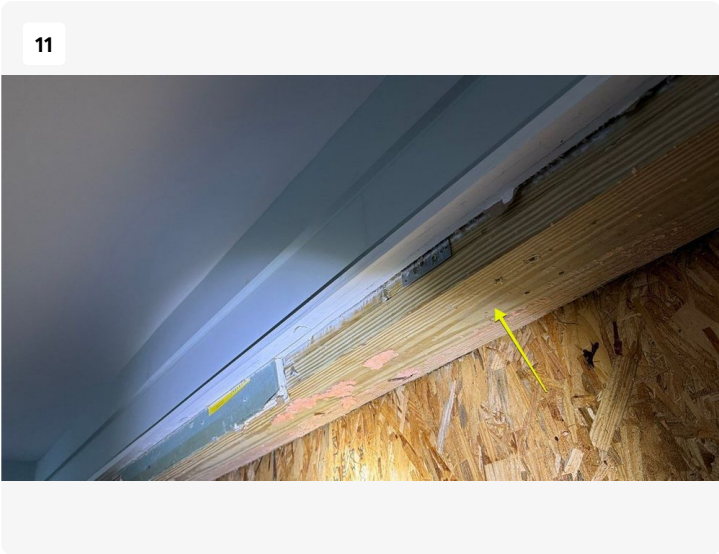
- d. The sliding glass door was removed and observed to have no flashing or waterproofing present on the opening.
  - e. No staining was observed on the north wall under the recently installed windows.

The sliding glass door on north balcony of the unit was removed and observed to have had no flashing or water-proofing installed on the rough opening.

1. The sliding glass doors and French door of Unit 701 should be pulled and the openings properly waterproofed before reinstalling the doors.
2. The French door of the unit does not appear to be properly sized and should be removed and replaced with a correctly sized door assembly.
3. The balconies of Unit 701 should be properly waterproofed.
4. The partition wall of Unit 701 should be fully sheathed and waterproofed with the waterproofing properly lapped/integrated into the balcony deck waterproofing.
5. The walkway of the 7<sup>th</sup> level should be waterproofed.
6. The drainpipe in Unit 603 should be properly terminated and capped. This will likely consist of a 90 degree elbow being installed at the current junction near the kitchen.

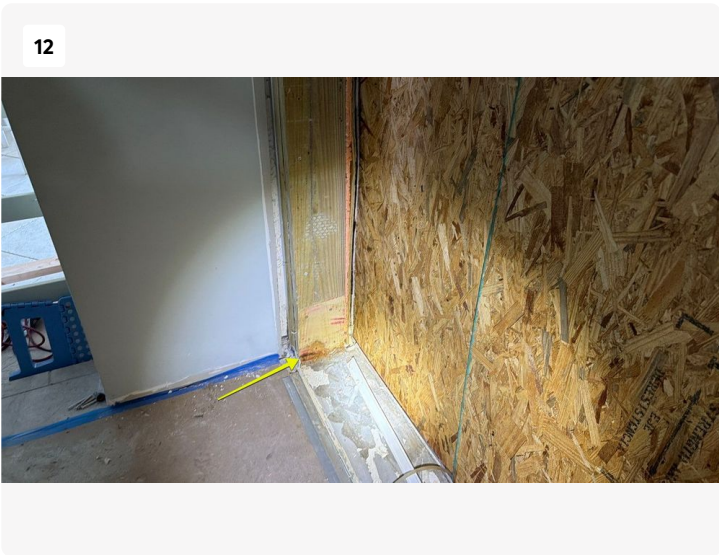
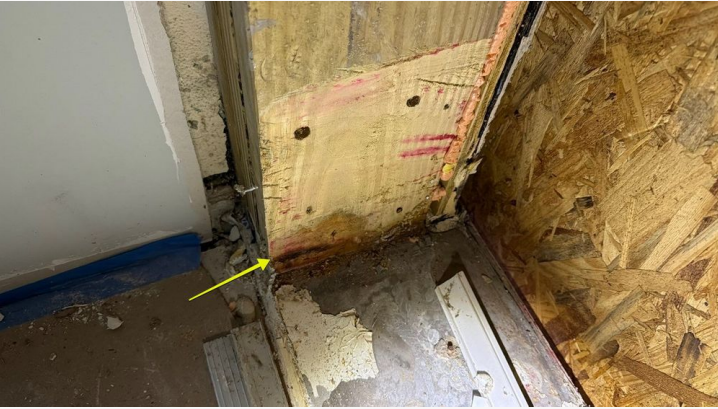
The sliding glass door on north balcony of the unit was removed and observed to have had no flashing or water-proofing installed on the rough opening. Staining consistent with moisture intrusion was observed on the lower corner of the sliding glass door opening.

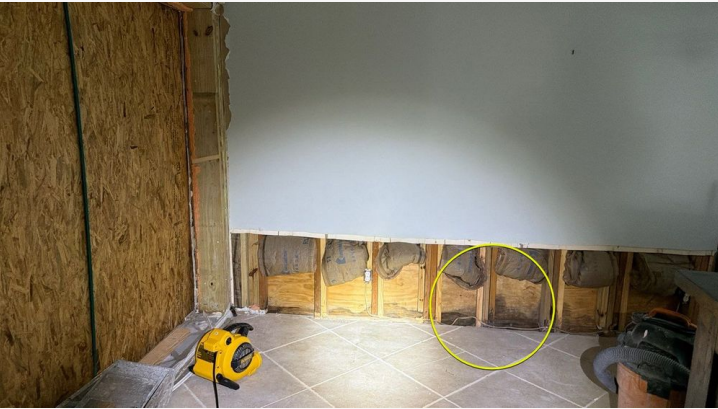
- f. No staining was observed to be running down the wall. Rather all the staining was observed at the base of the wall and appeared to be caused by capillary action.

The north exterior wall of the Unit 701 was observed to have staining present along the base of the wall. It was noted that no drip marks or staining from higher up were observed, indicating that the staining was coming from moisture at the base of the wall being absorbed via capillary action, rather than running down the wall from above. Additionally, the staining was observed to decrease the further from the sliding glass door. A concentration in the staining was observed approximately 6-8' to the east of the sliding glass door which correlated with the location of the leaks in 602 below. This area ap...

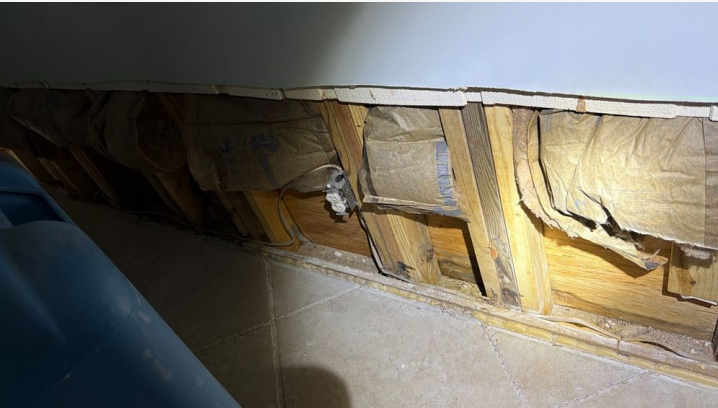
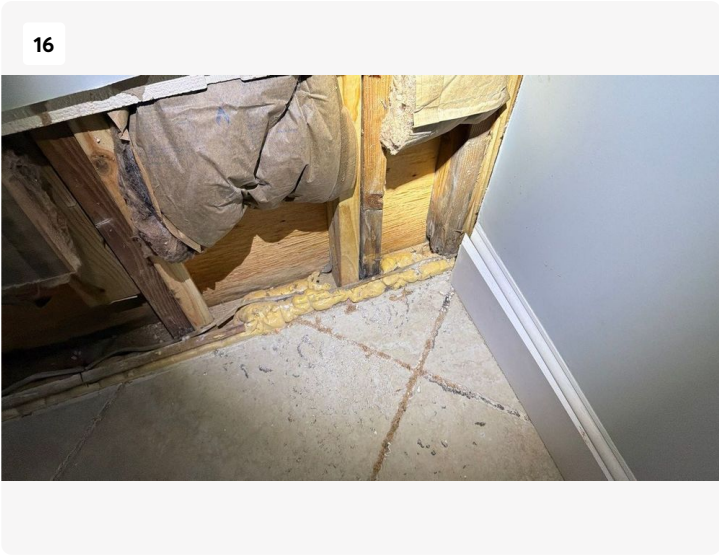
The degree of staining appeared to lessen as you moved further from the sliding glass door.

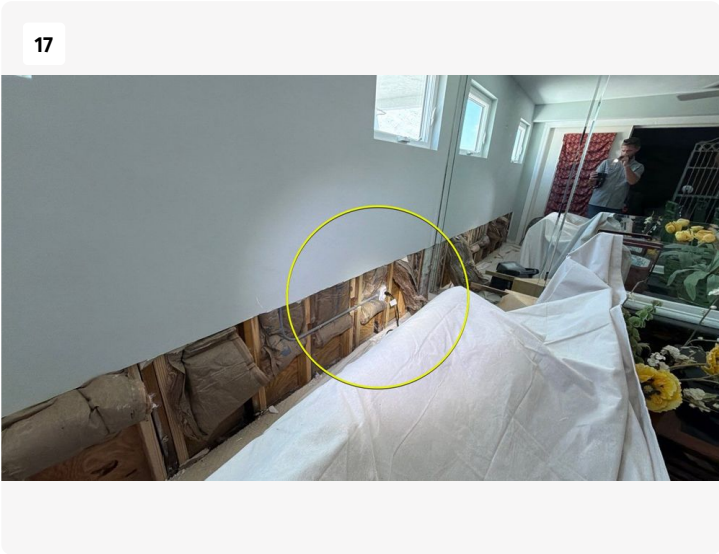
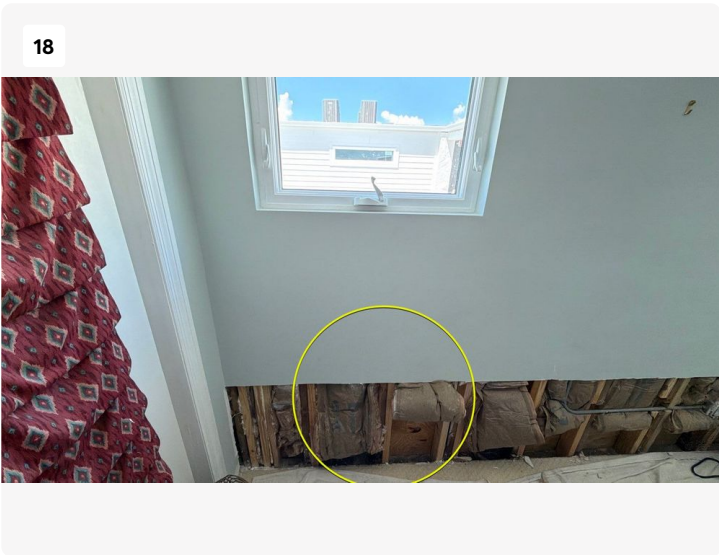
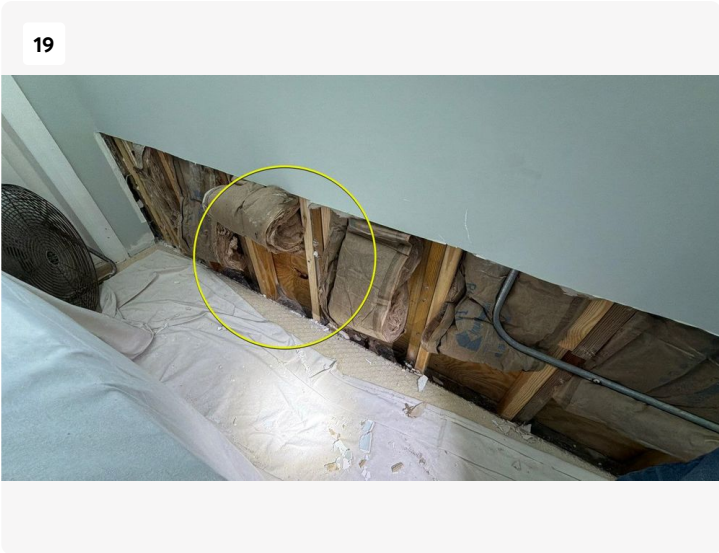
The degree of staining appeared to lessen as you moved further from the sliding glass door. There was no staining observed under the windows in the east room of Unit 701 or along the base of the wall.

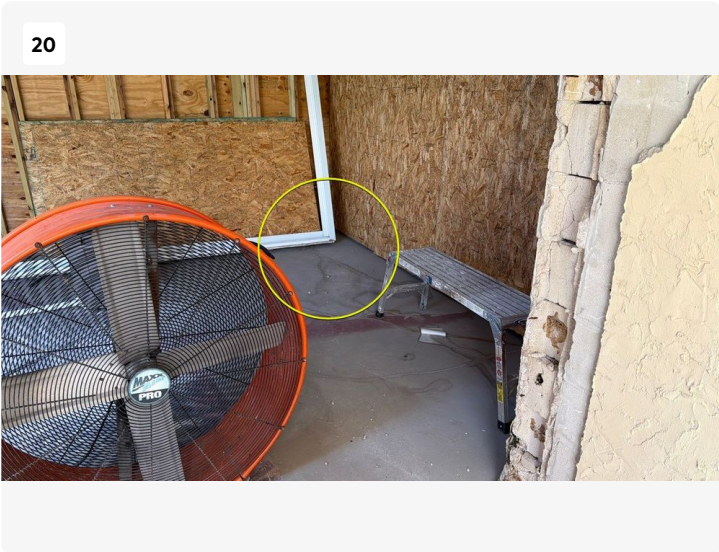
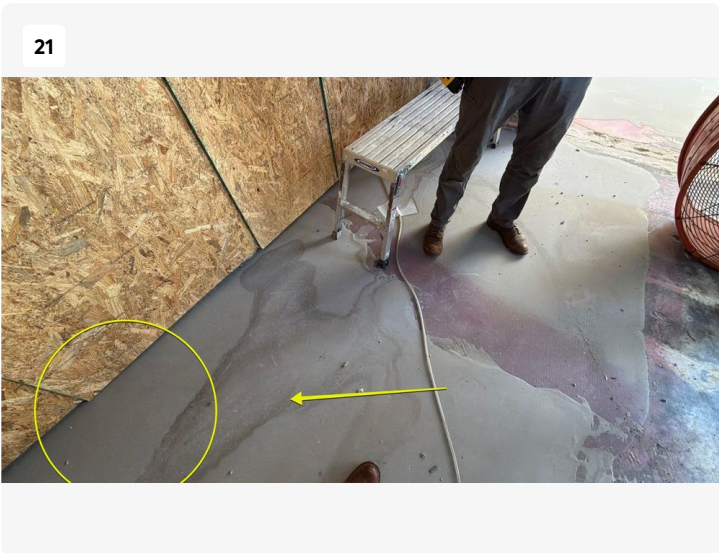
- g. The north balcony of the unit was reported to have an improper slope causing water to collect in the northwest corner adjacent to the sliding glass door.

The north patio deck of Unit 701 was reported to have had a significant dip towards the northeast causing water to accumulate directly against the base of the sliding glass door. The contractor added sloping material to assist in moving water away from the sliding glass door and towards the scuppers on the west side of the deck.

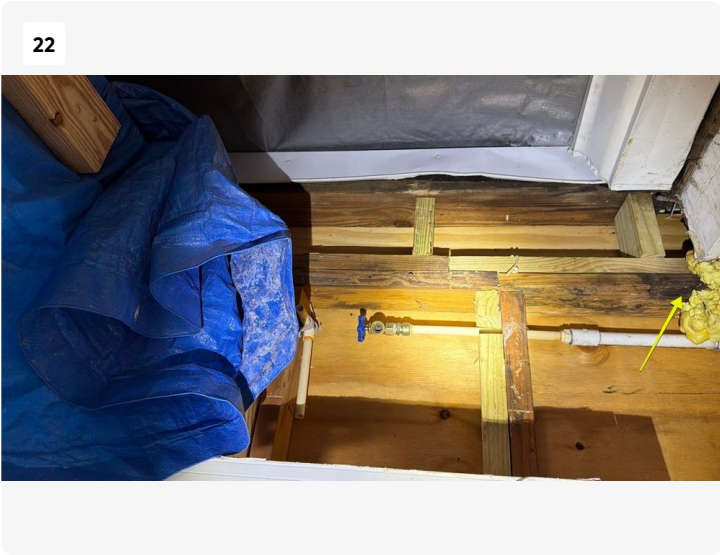
Staining was observed in the upper portion of the wall immediately adjacent to the sliding glass door. A water supply line was also observed in this location and was reported to have been capped due to leaks that were observed during demolition.

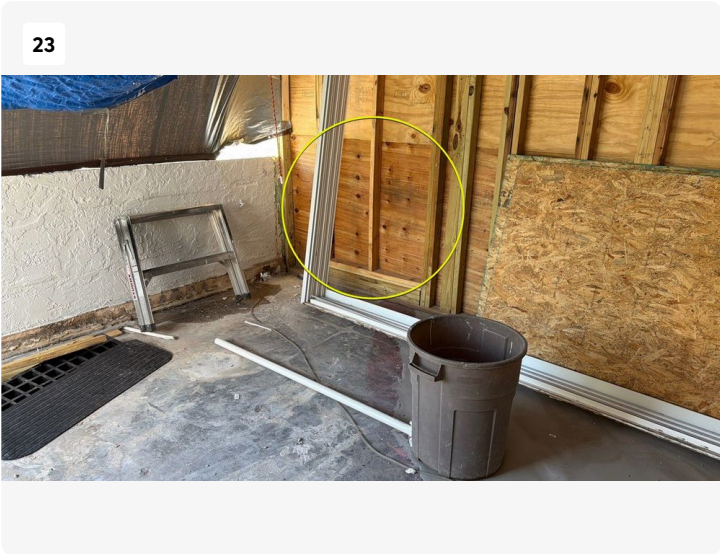
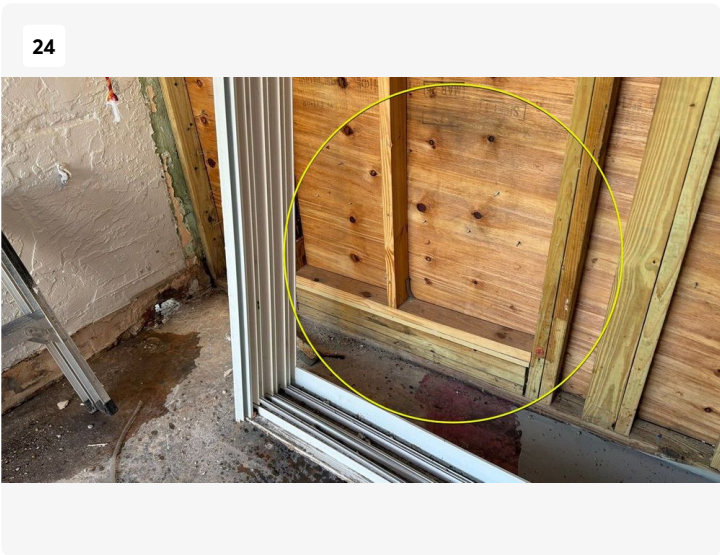
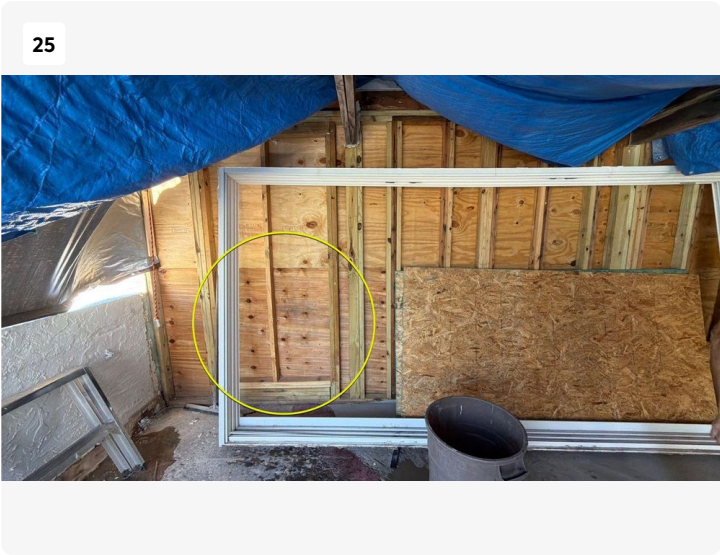
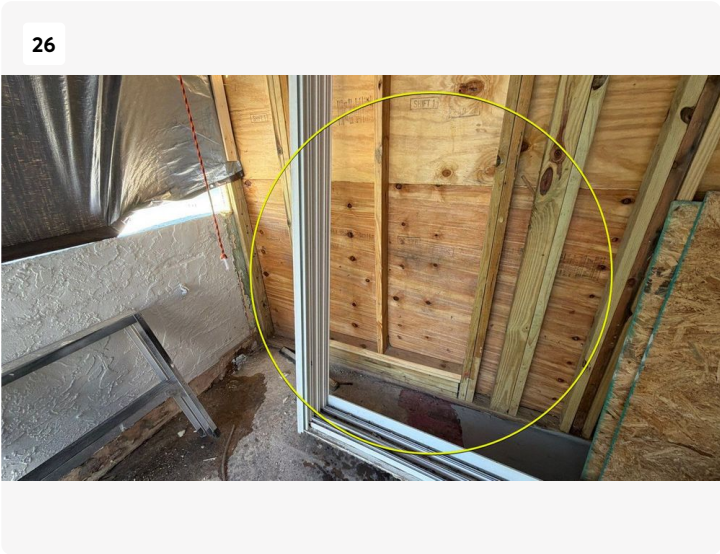
The interior face of the north partition wall of Unit 701 was exposed and observed to be free of staining. It is important to note that the wall and roof in this location was the same construction as all other locations along this roof.

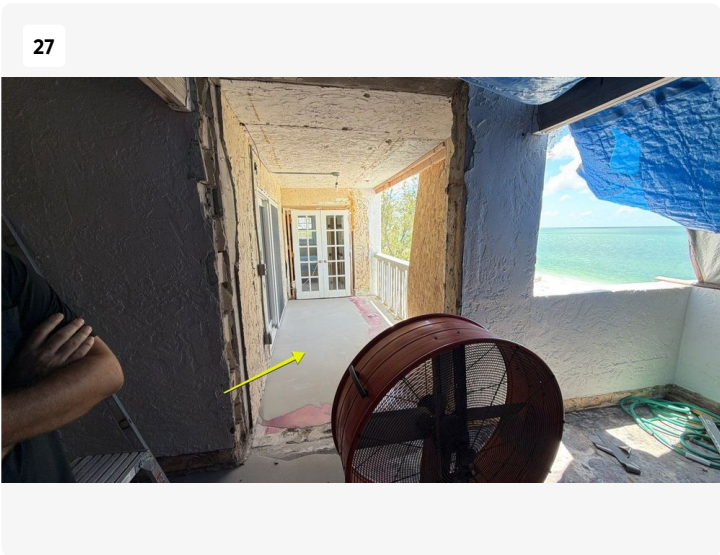
- j. The deck of the balconies was currently stripped and had supplemental sloping applied with no waterproofing or caulking present.
  - k. The contractor had installed tarps and plywood to mitigate water from entering the balcony. The owner of 602 had reported that since this was done the leaks in the unit had stopped/reduced.

The south deck of Unit 701 was observed to have been stripped with no waterproofing or caulking currently present. Sheathing had been installed on the exterior of the building to mitigate water from entering the balcony. One piece of sheathing was reported to have become dislodged and was removed.

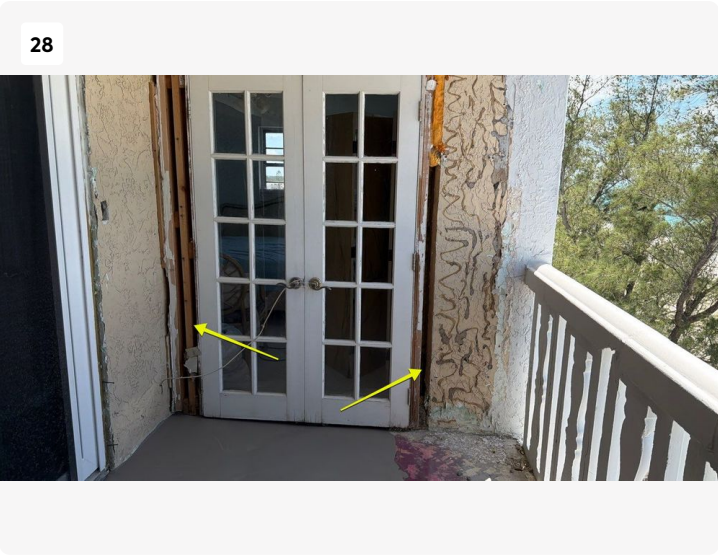
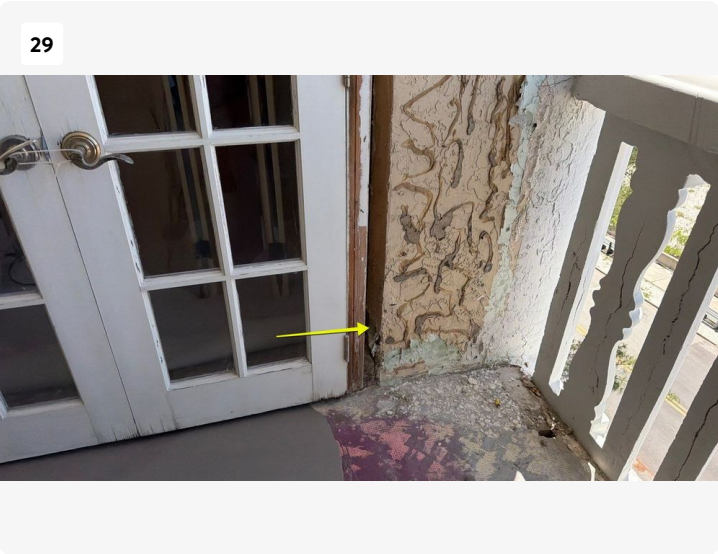
- h. The south French door of the balcony was observed to have been improperly installed with large gaps and a lack of waterproofing or flashing.
  - i. The south sliding glass door was observed to have been improperly installed with no gaps and a lack of waterproofing or flashing.

The south french door of the balcony on Unit 701 was observed to be exposed with large gaps around the perimeter of the door and no flashing or waterproofing present.

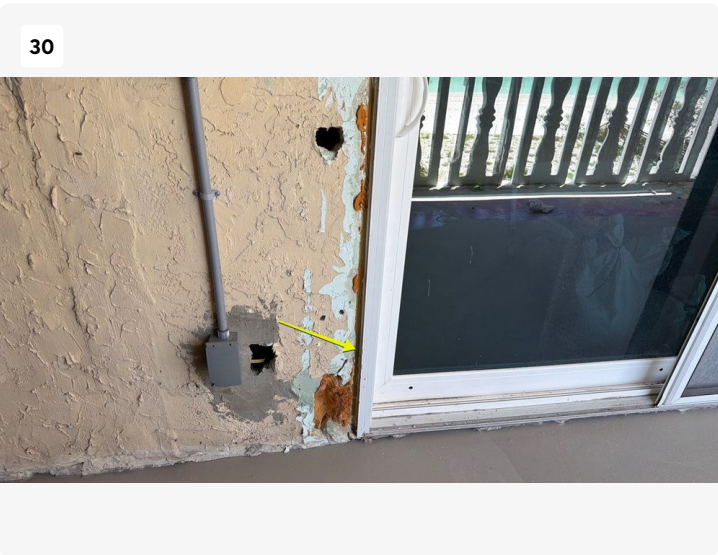
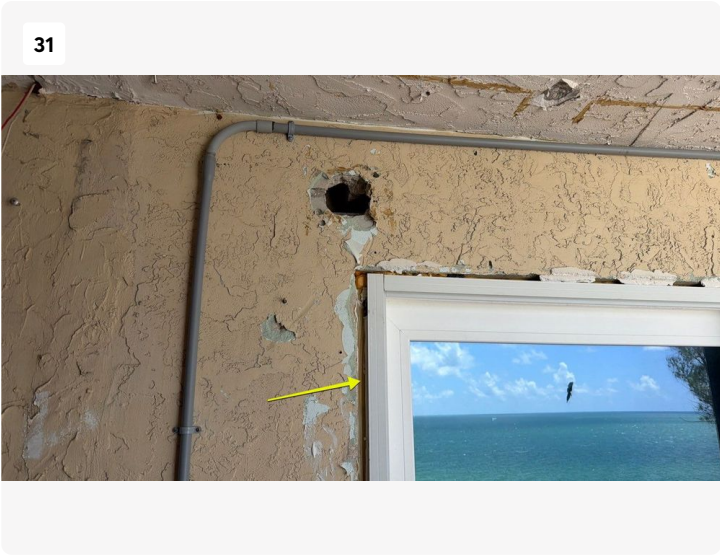
The south sliding glass door of the balcony on Unit 701 was observed to be exposed with gaps around the perimeter of the door and no flashing or waterproofing present.

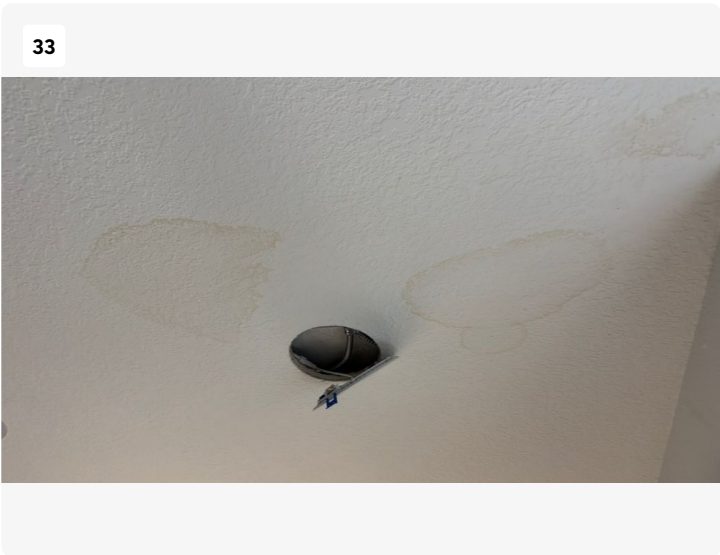
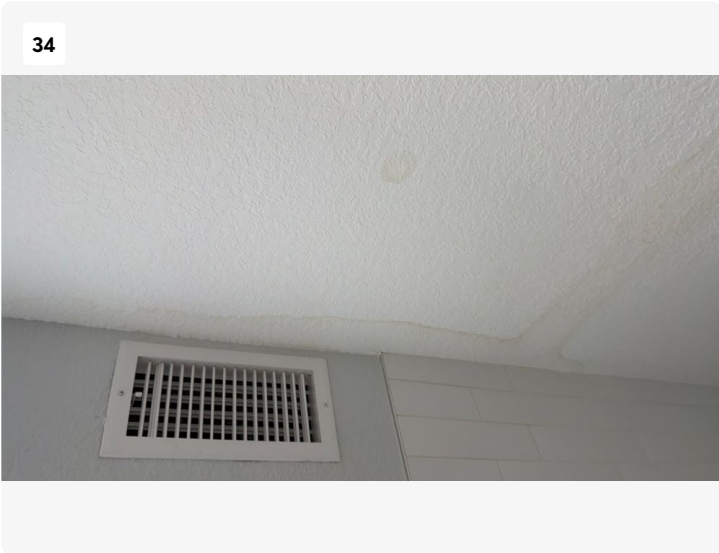
Multiple areas of staining were observed in the ceiling.- This correlated with the currently unsealed walkway decks on the 7th level above.

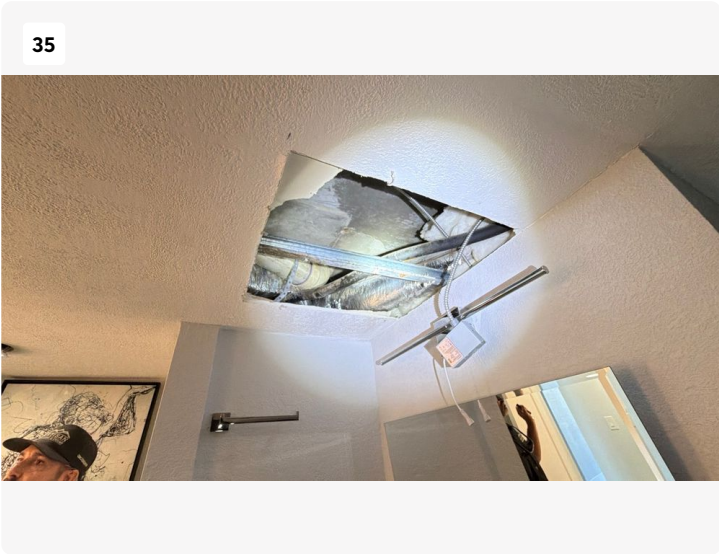
A portion of the ceiling in the master bathroom was pre-  
viously removed due to reported leaks in this location.

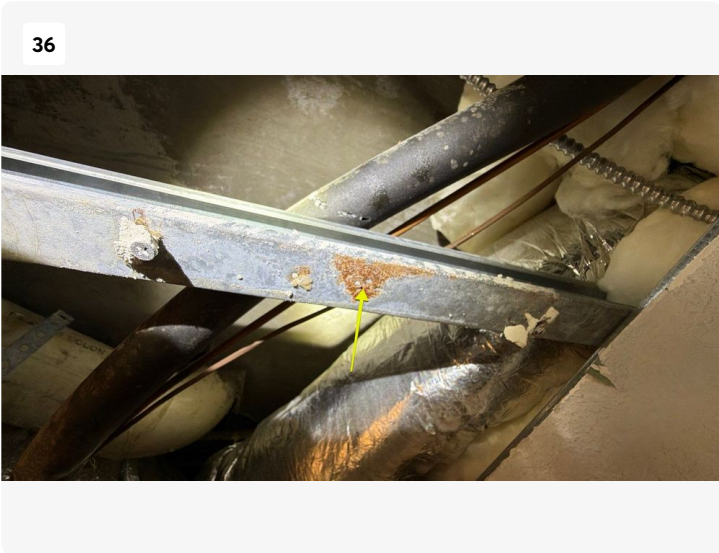
Corrosion was observed in portions of the ceiling framing.

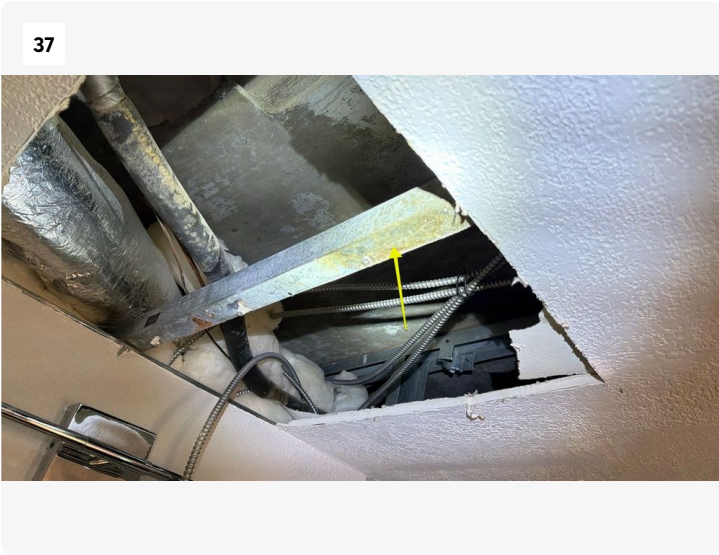
Staining was observed on portions of the ceiling framing.

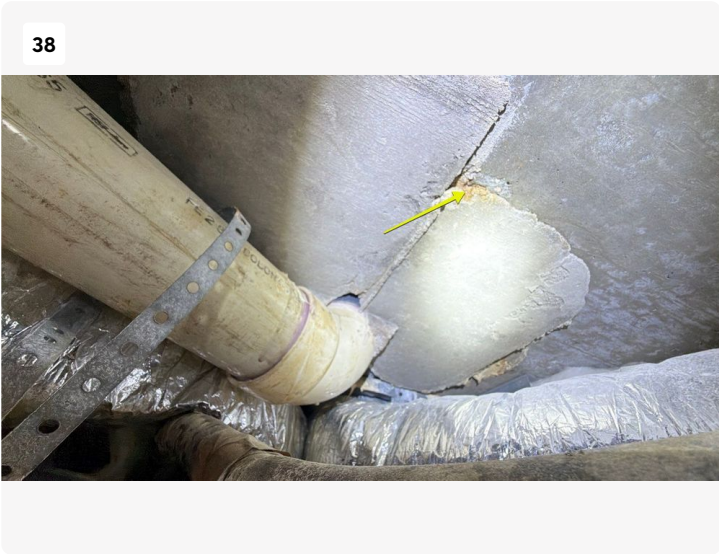
Staining was observed around portion of the deck patching material.

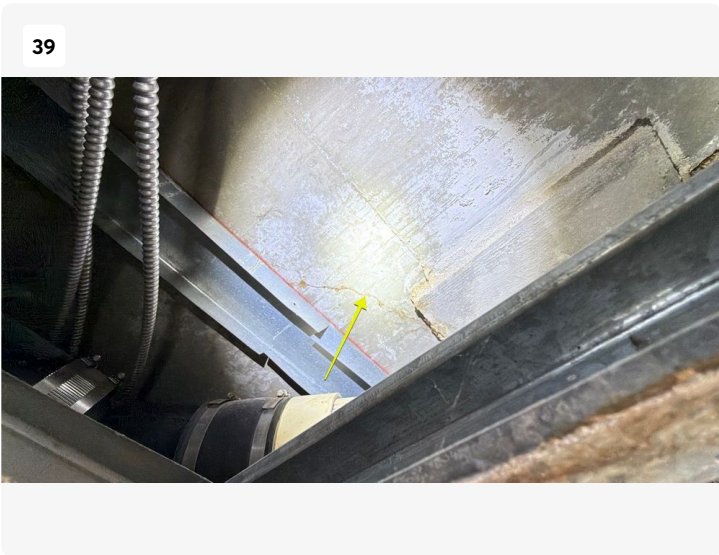
Staining was observed along a crack in the deck above.

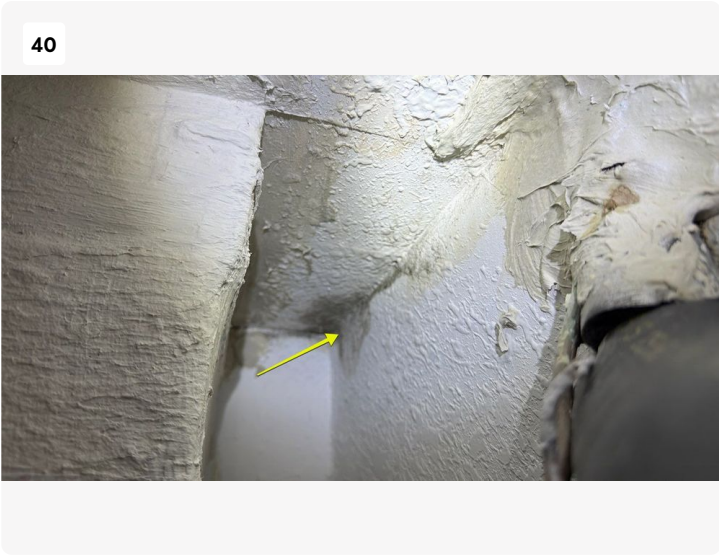
Staining consistent with moisture intrusion was observed in the a/c closet immediately adjacent to the removed portion of the ceiling in the master bathroom.

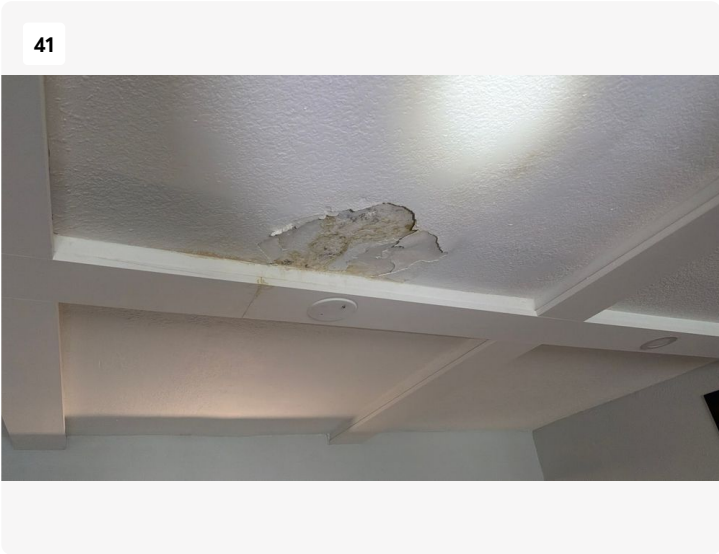
Staining and finish deterioration was observed in the family room directly above the dining table.

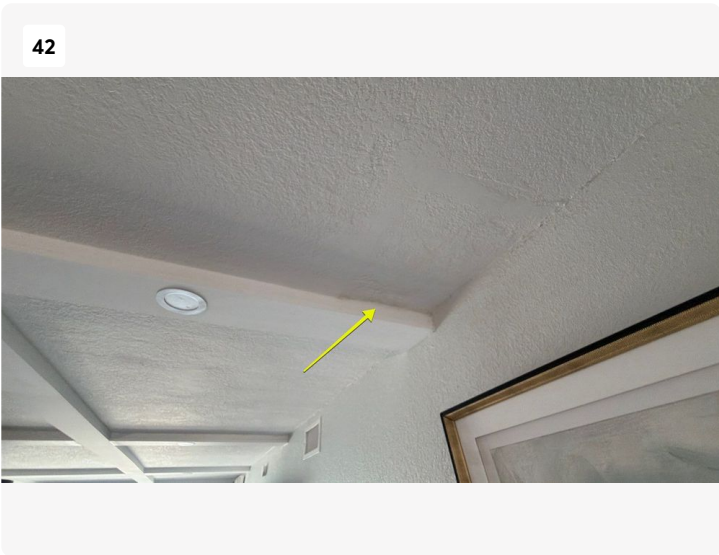
Staining was observed along the wall to ceiling interface in the family room directly in line with the ceiling leak above the dining table and the area of removed ceiling in the master bathroom. An apparent ceiling patch was also observed in this location.

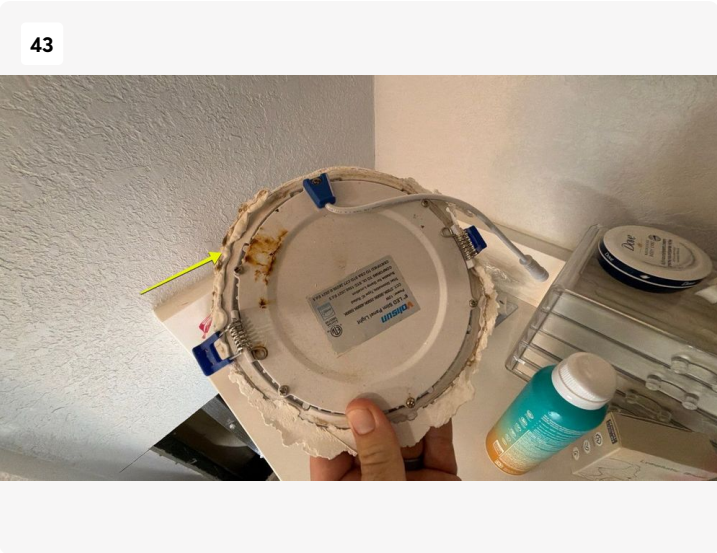
Corrosion and caulking were observed on the back of the ceiling light that was removed in the same area where the ceiling in the master bathroom was removed.

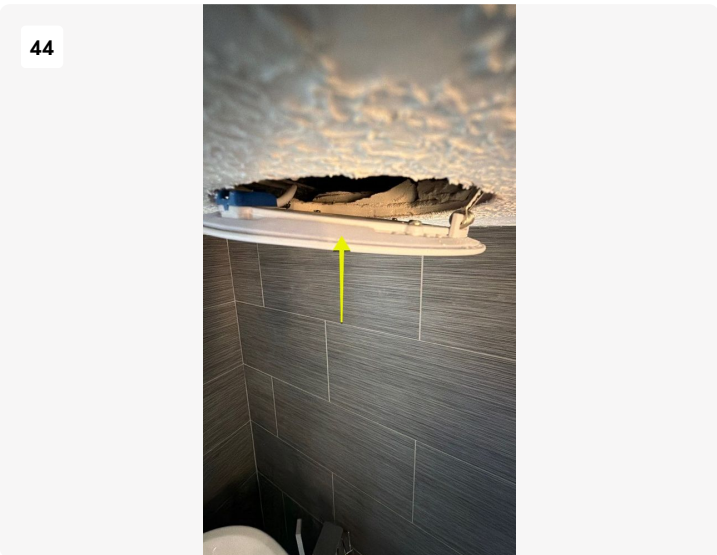
The other ceiling lights in the master bathroom were observed to not have any caulking present.

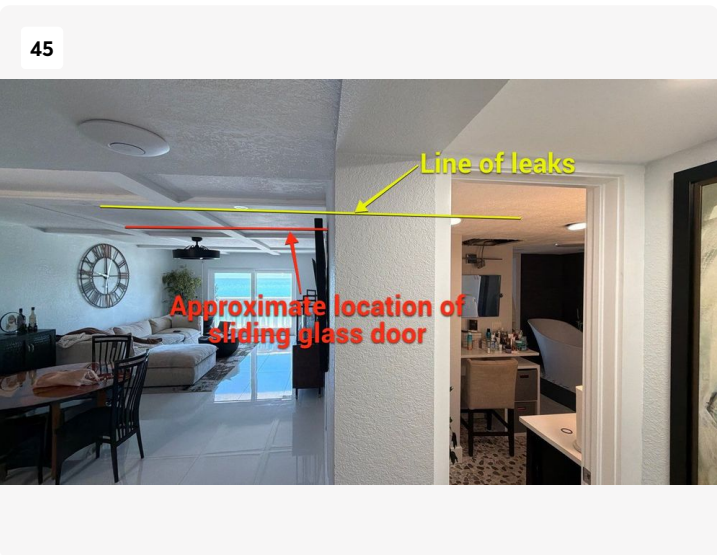
The location of the staining was found to align with the area of concentrated staining in the base of the wall of Unit 701 above. This appeared to have been caused by the leak through the sliding glass door assembly of the unit.

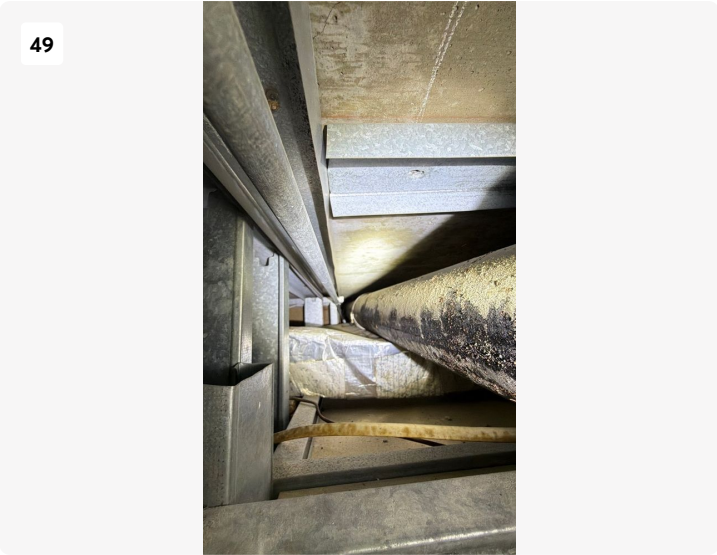
- d. The roof drain has since been covered over with drainage being provided via scuppers.
  - e. The capped end of the drainpipe was continuous horizontally and reported by the unit owner to extend under Unit 704.

The drain line was observed to be continuous towards the underside of Unit 704.

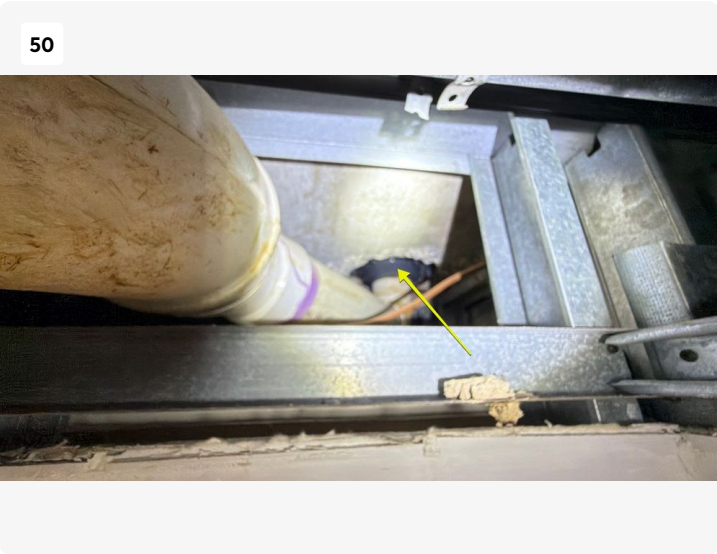
The lower roof drain that was later roofed over.

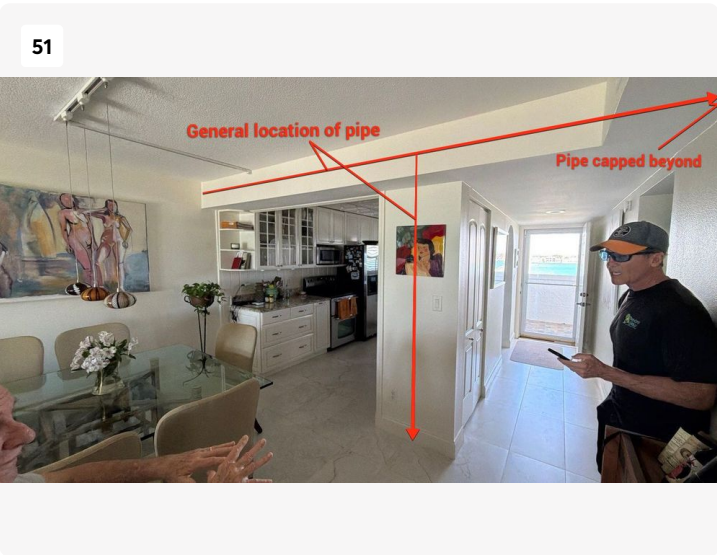
The owner indicated that during a previous remodel of his unit he observed and drainage pipe in his wall that ran laterally under Unit 704.
