PRESCOTT ENGINEERING, LLC

September 5, 2025

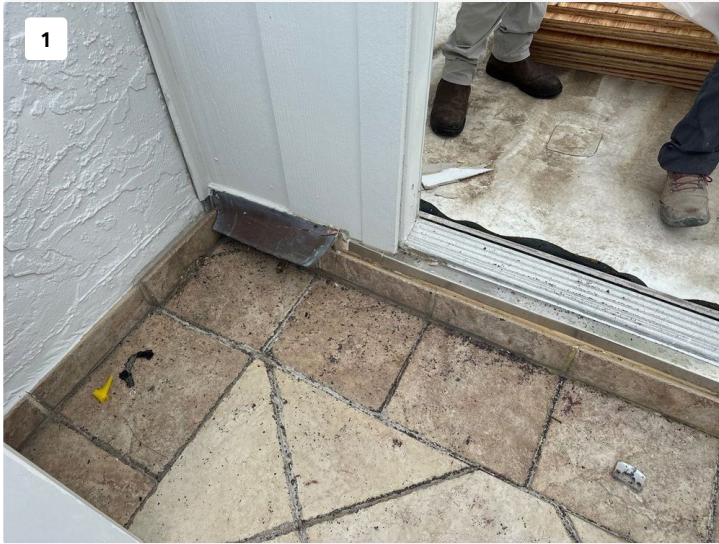
Large balcony of Unit 701 base of wall. Vertical tile has separations present along base of existing opening.

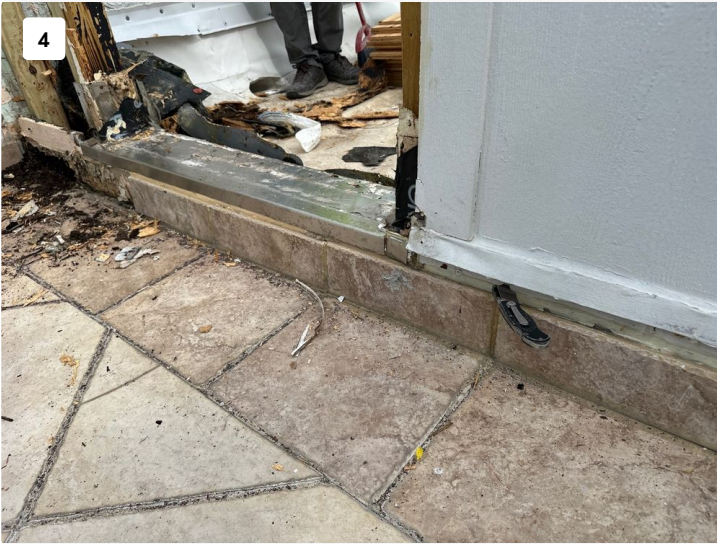
Vertical tile observed to have been installed overtop wood board only. No flashing present along the base of the wall.

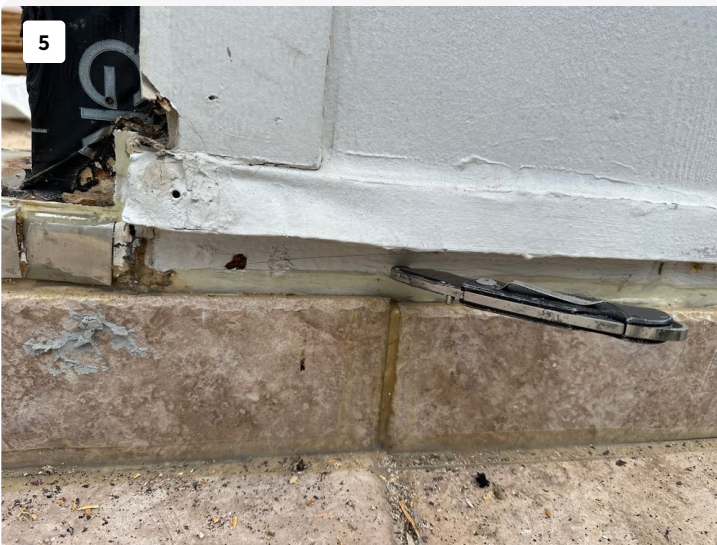
Vertical tile observed to have been installed overtop wood board only. No flashing present along the base of the wall.

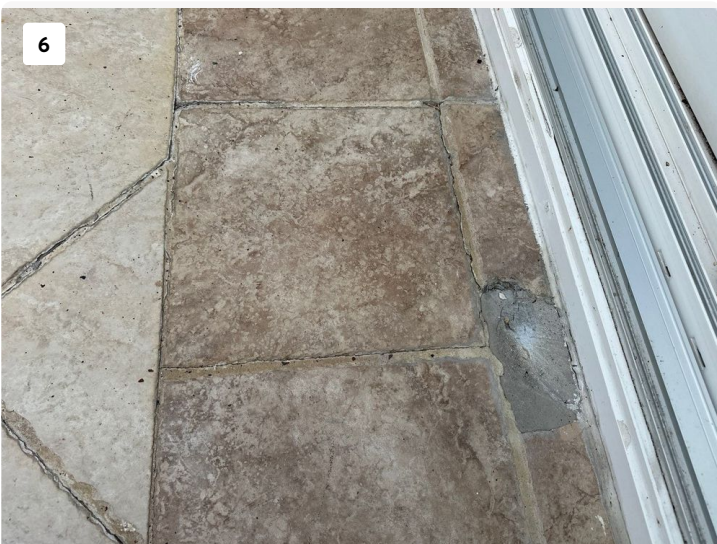
Tiles adjacent sliding glass door delaminated with wide-spread cracking in grout. Previous tile patch repair attempts.

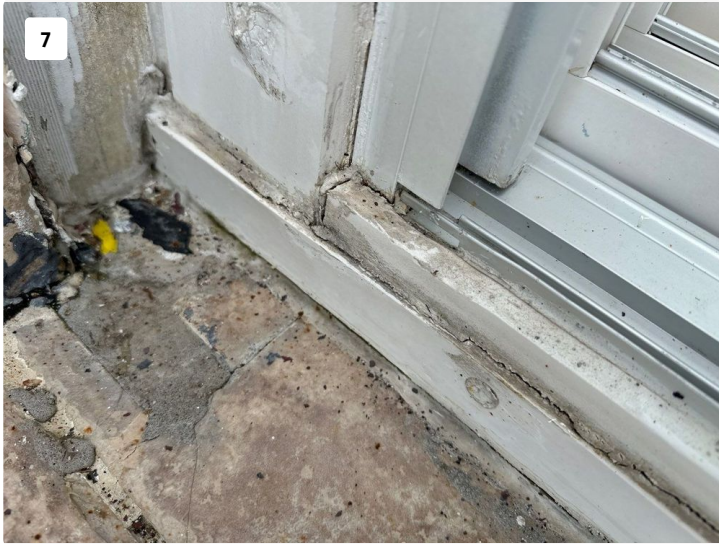
7 Heavy use of sealant along base of sliding glass door with widespread deterioration of sealant and separations present.

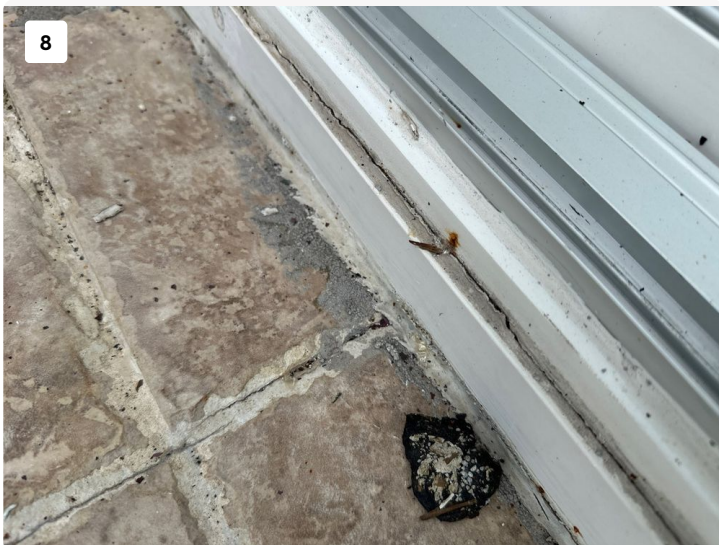
8 Heavy use of sealant along base of sliding glass door with widespread deterioration of sealant and separations present.

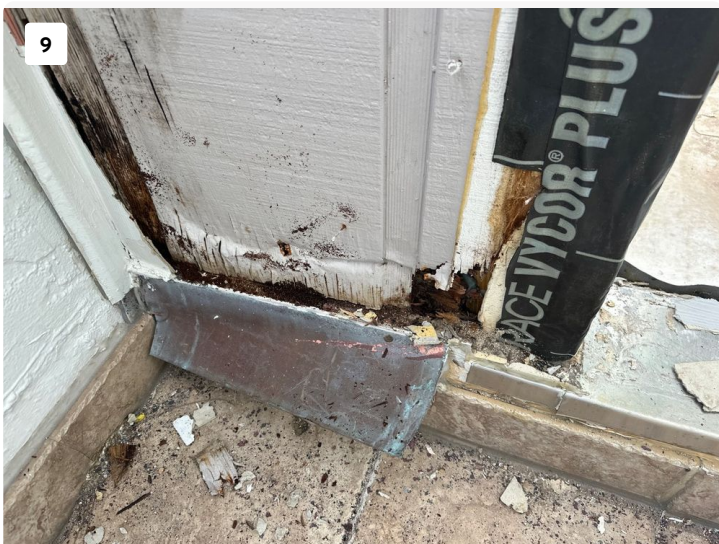
9 Upon removal of the hardieboard finish on sides of balcony door on 701 deterioration of covered T1-11 siding that was observed.

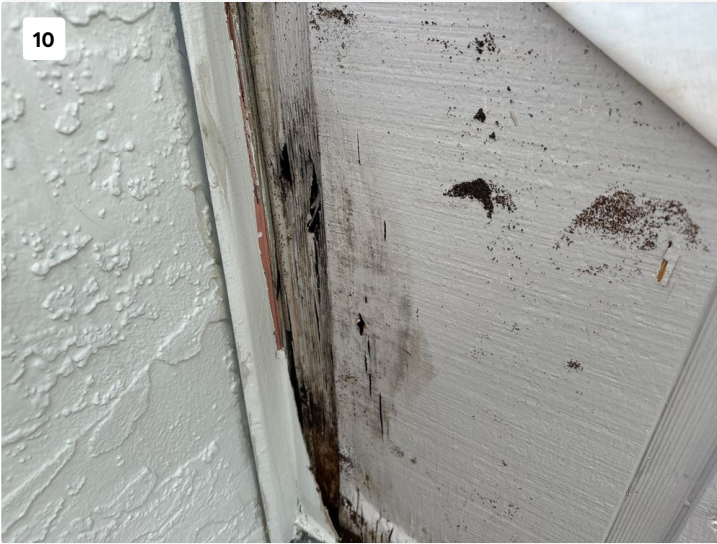
Upon removal of the hardieboard finish on sides of balcony door on 701 deterioration of covered T1-11 siding that was observed.

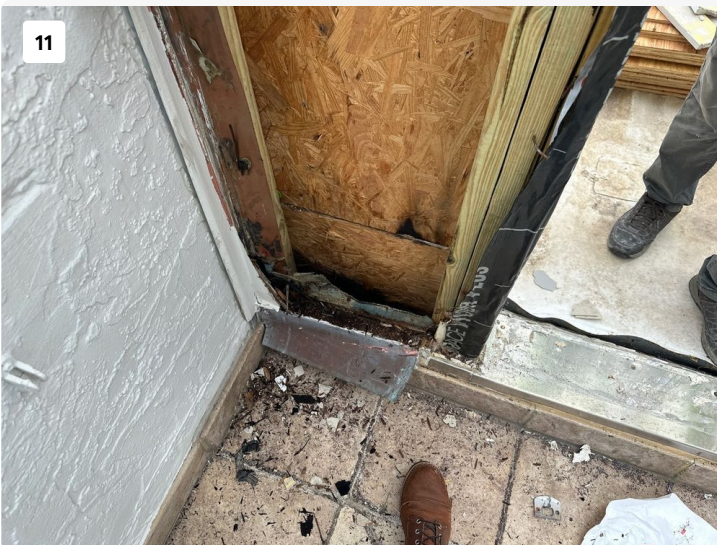
Apparent previous framing repairs along side of door as well as deterioration of oriented strand board (OSB) sheathing under wall finishes.

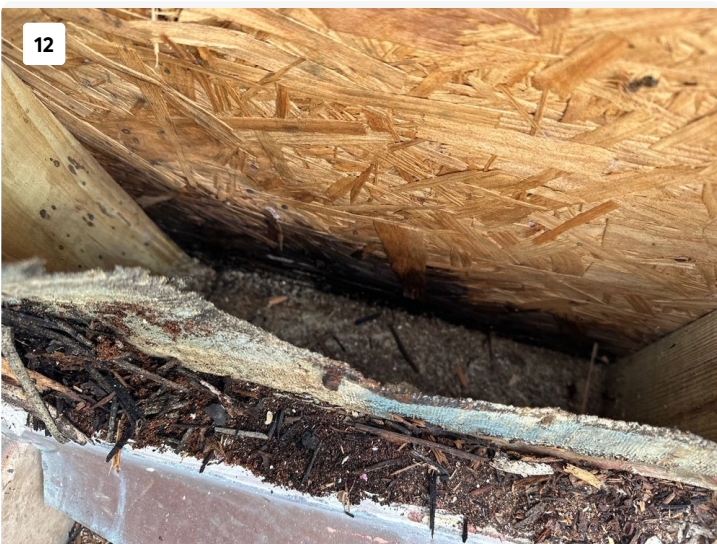
Apparent previous framing repairs along side of door as well as deterioration of oriented strand board (OSB) sheathing under wall finishes.

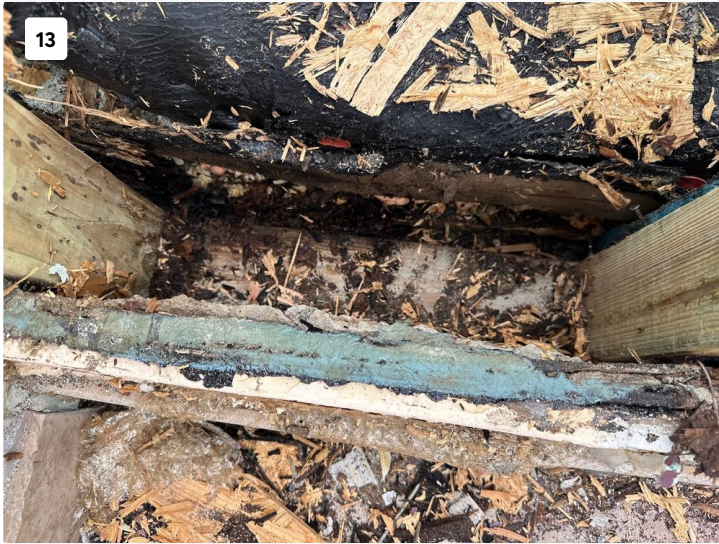
Apparent previous framing repairs along side of door as well as deterioration of oriented strand board (OSB) sheathing under wall finishes.

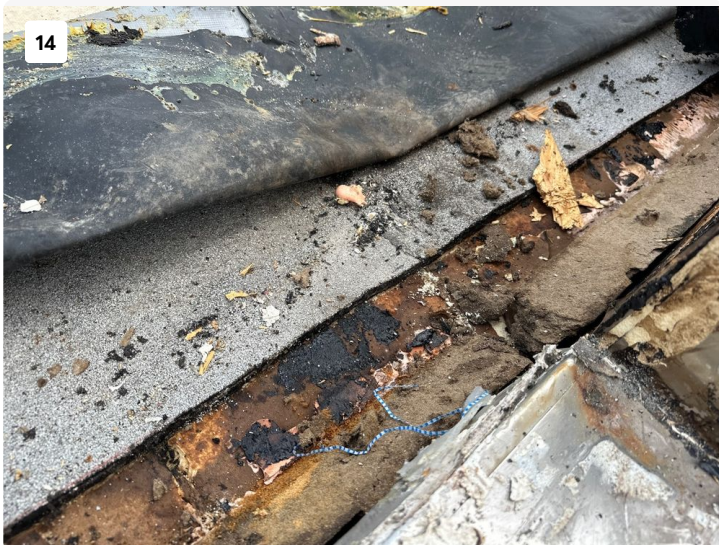
Insulation board on lower roof area on side of 701 found to have widespread areas of trapped moisture.

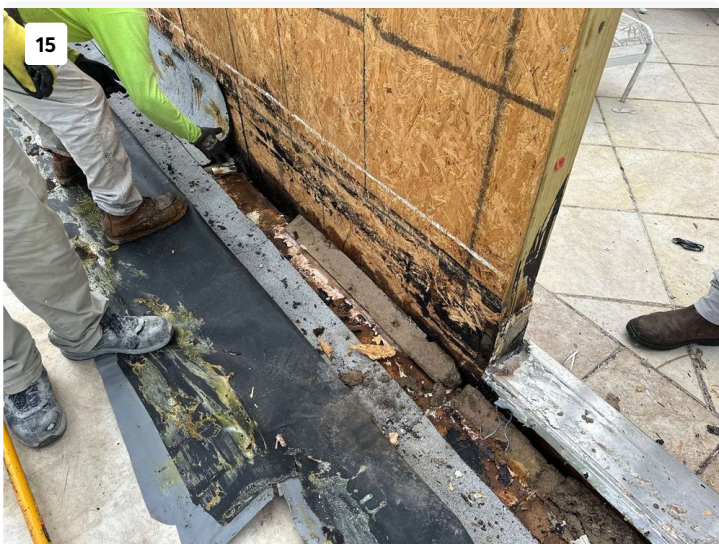
Insulation board on lower roof area on side of 701 found to have widespread areas of trapped moisture.

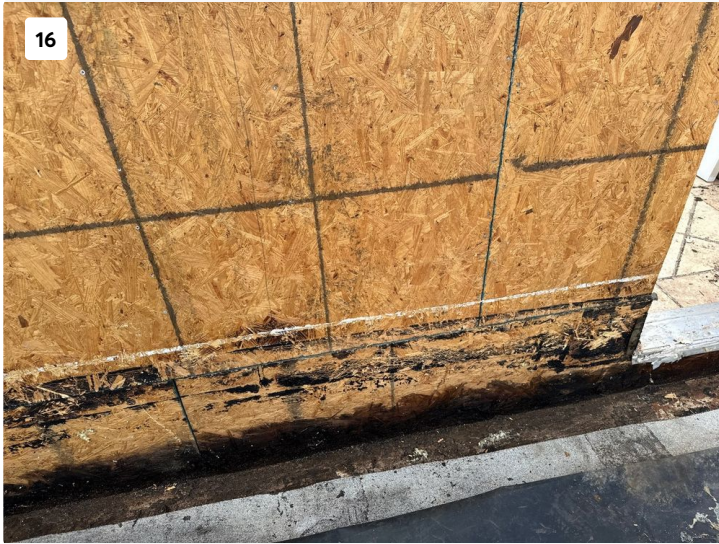
Base of OSB sheathing on 701 wall adjacent to lower roof found to have widespread deterioration along the base.

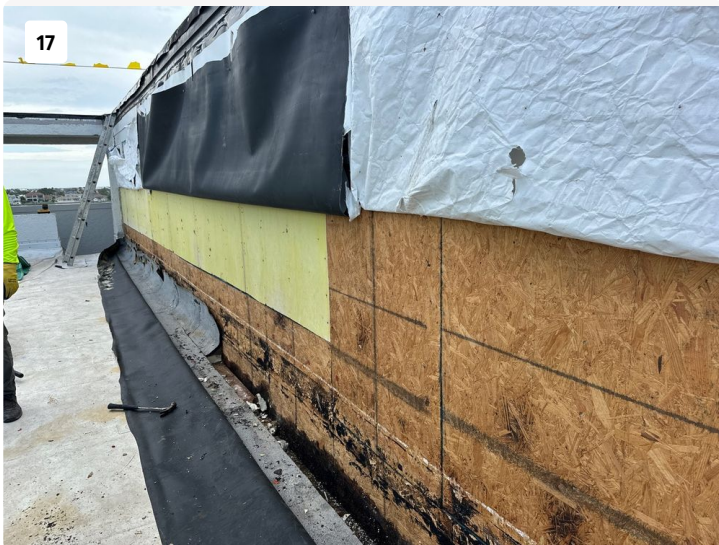
Base of OSB sheathing on 701 wall adjacent to lower roof found to have widespread deterioration along the base.

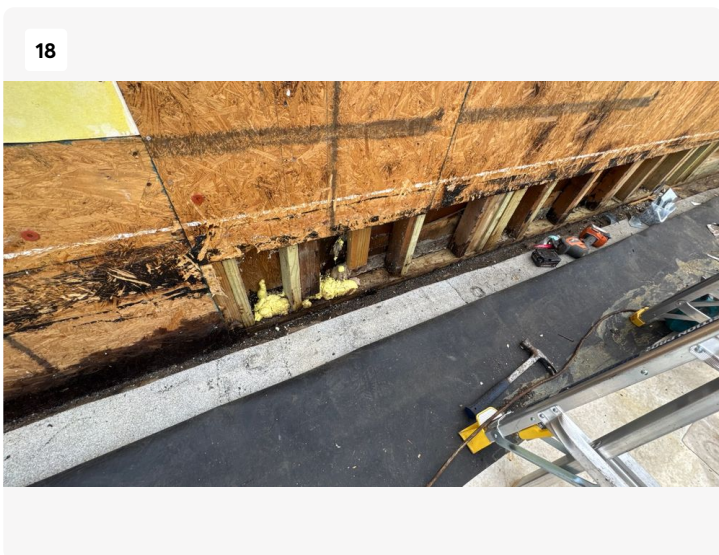
Base of OSB sheathing, wall bottom plate, and vertical studs on 701 wall adjacent to lower roof found to have widespread deterioration along the base.

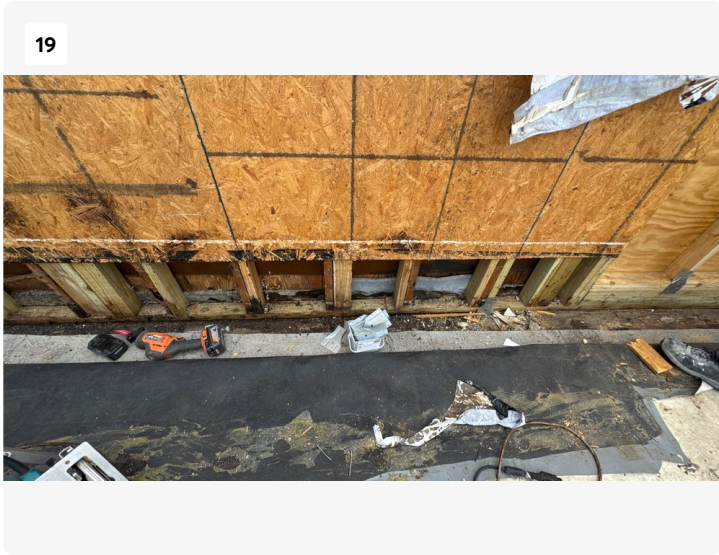
19 Base of OSB sheathing, wall bottom plate, and vertical studs on 701 wall adjacent to lower roof found to have widespread deterioration along the base.

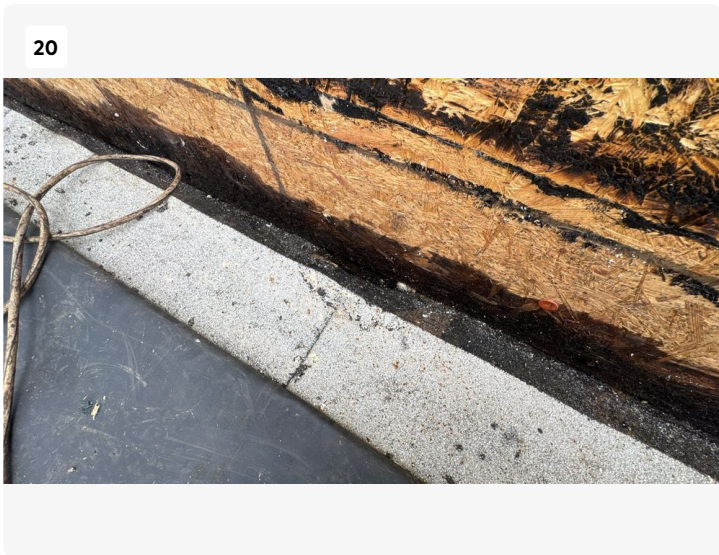
20 Base of OSB sheathing, wall bottom plate, and vertical studs on 701 wall adjacent to lower roof found to have widespread deterioration along the base.

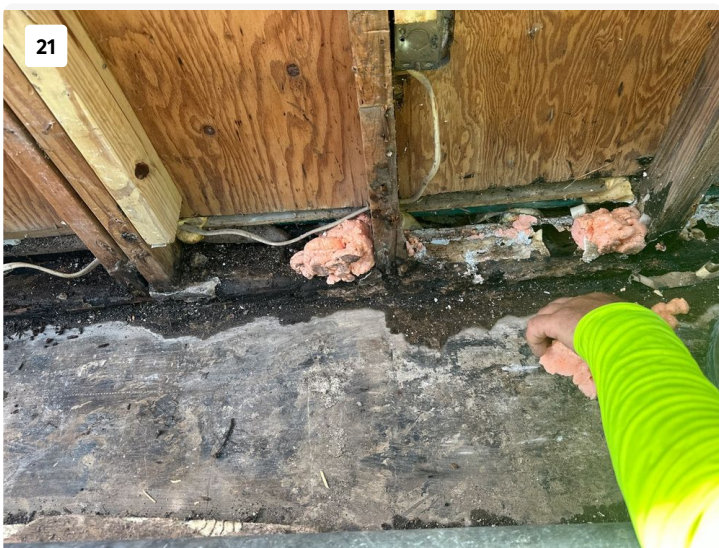
21 Water observed to continuously leach out from under interior tile of Unit 701 into low roof area.

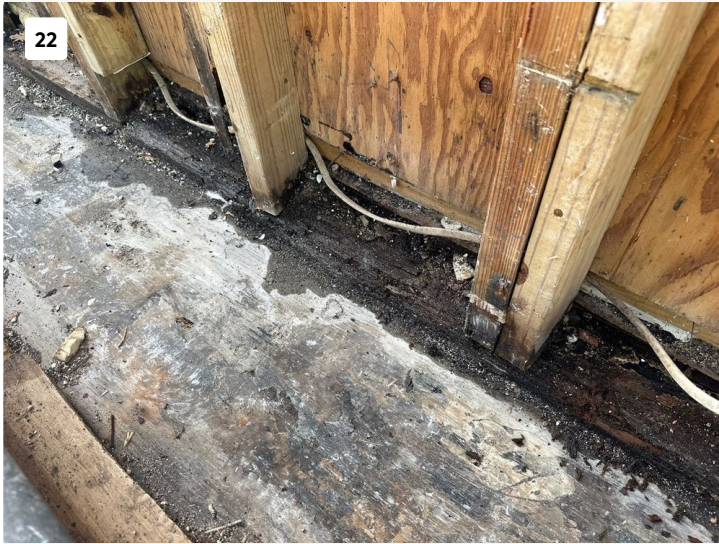
22 Water observed to continuously leach out from under interior tile of Unit 701 into low roof area.

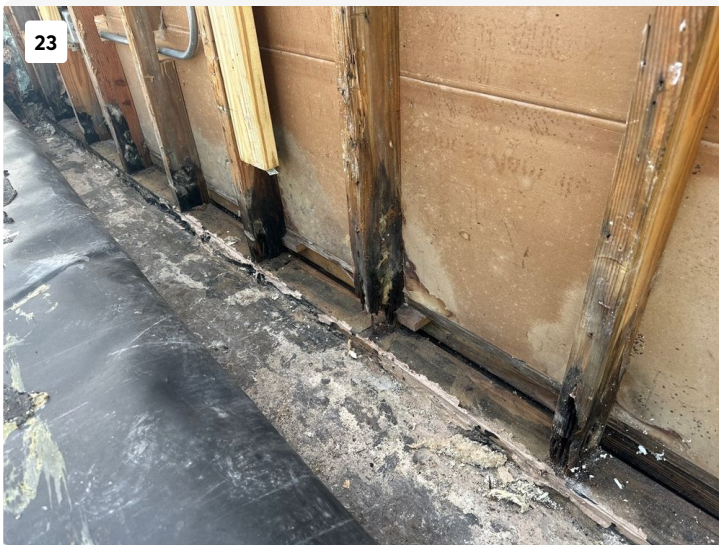
23 Widespread deterioration of base of vertical studs on wall of Unit 701. Portions appeared to have previous repairs on studs.

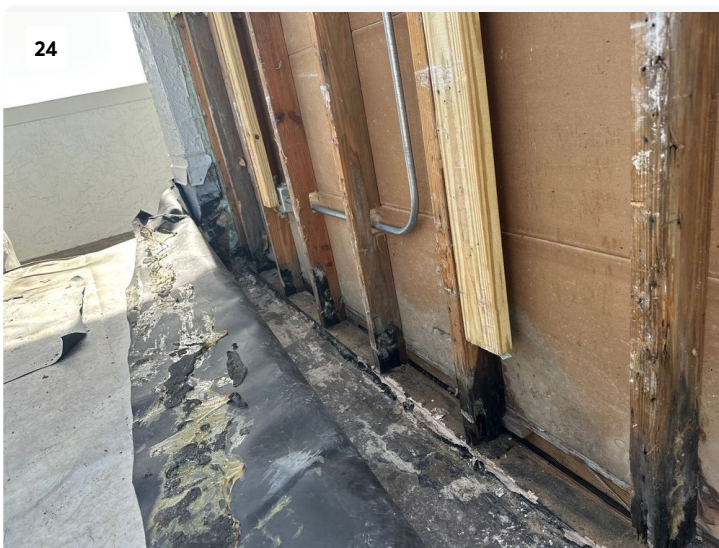
24 Widespread deterioration of base of vertical studs on wall of Unit 701. Portions appeared to have previous repairs on studs.

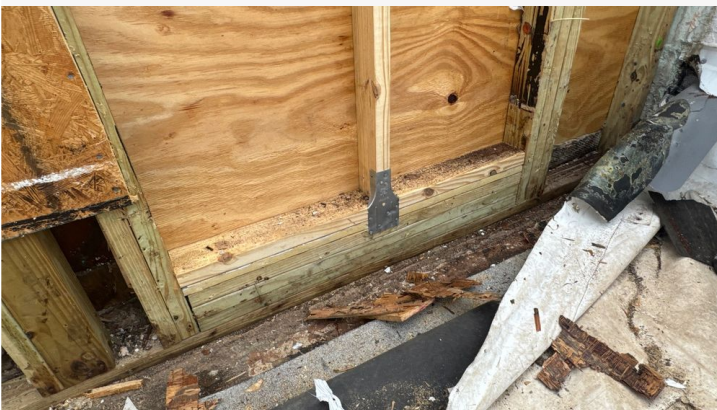
Framing repairs and hurricane clip installation.

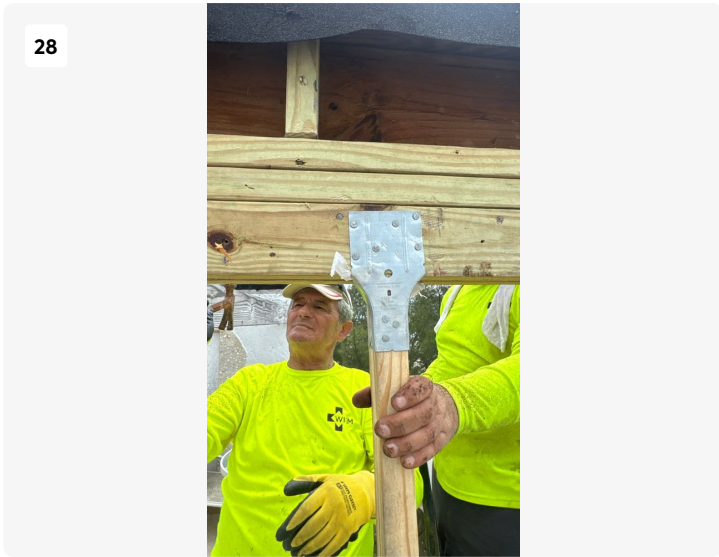
Framing repairs and hurricane clip installation.

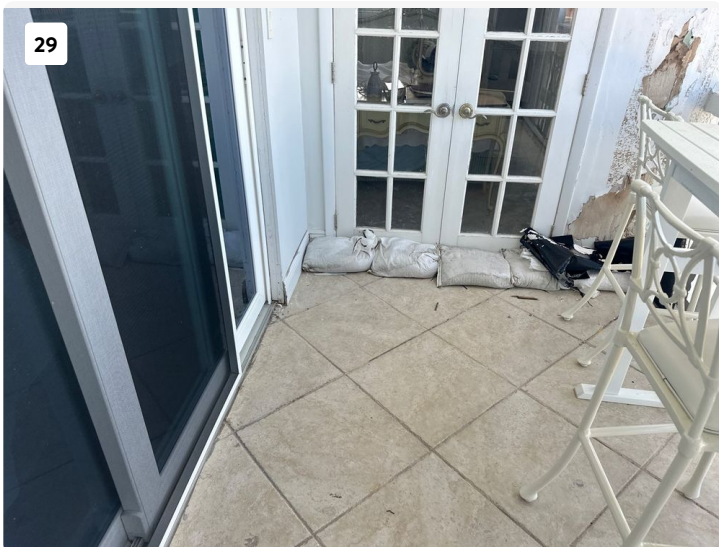
Small balcony of Unit 701.

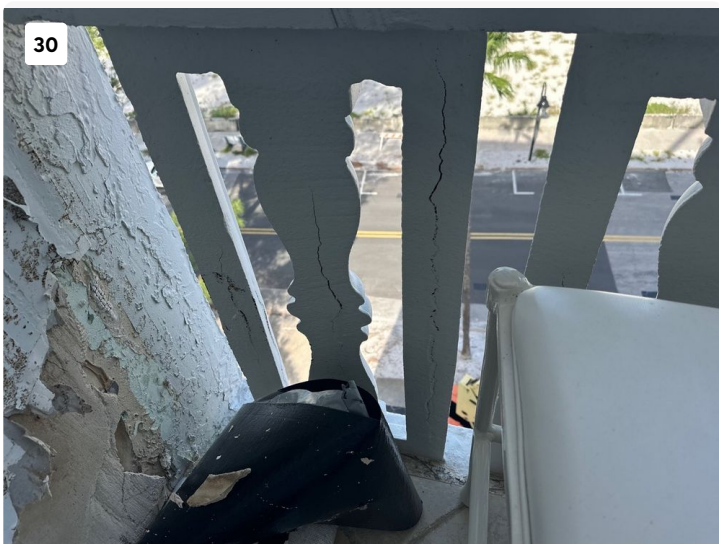
Widespread spalling of rails on balcony on 701.

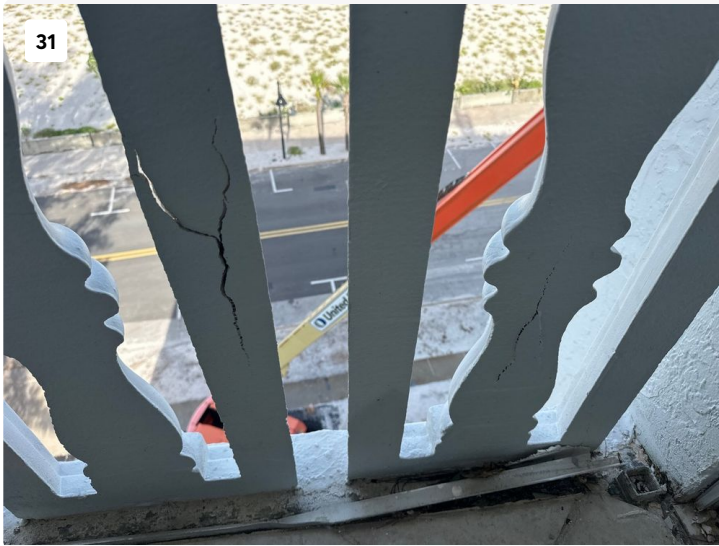
Widespread spalling of rails on balcony on 701.

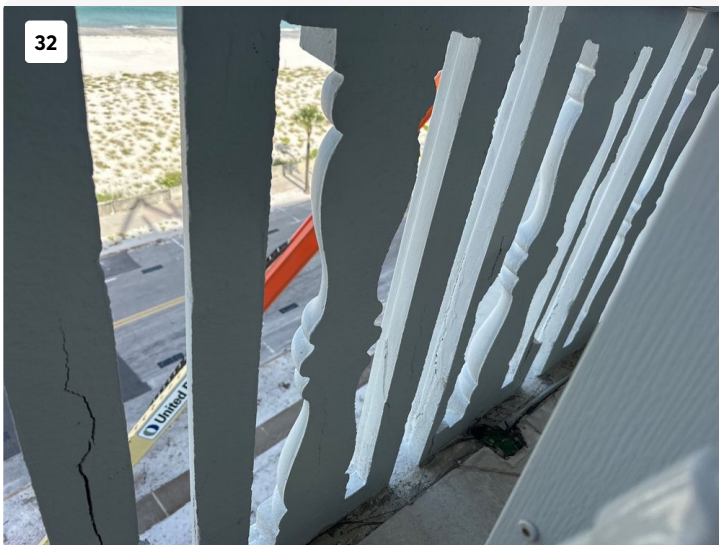
Widespread spalling of rails on balcony on 701.

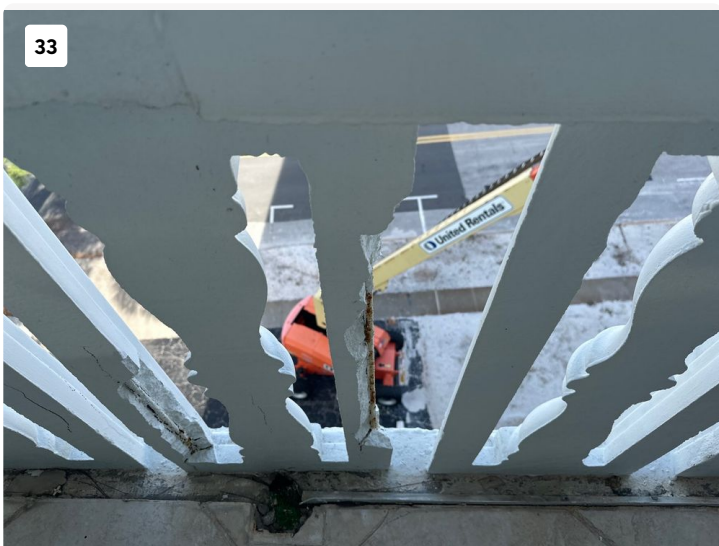
Widespread spalling of rails on balcony on 701.

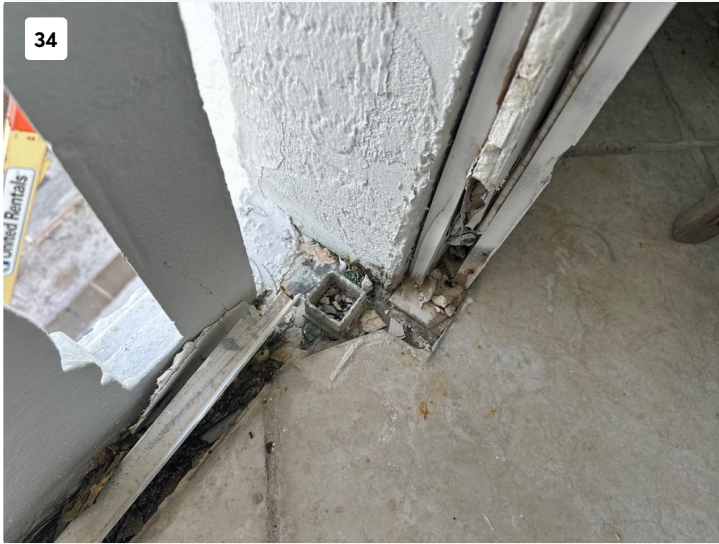
Multiple layers of drywall installed on the exterior walls of small balcony. Unsealed penetrations observed on balcony.

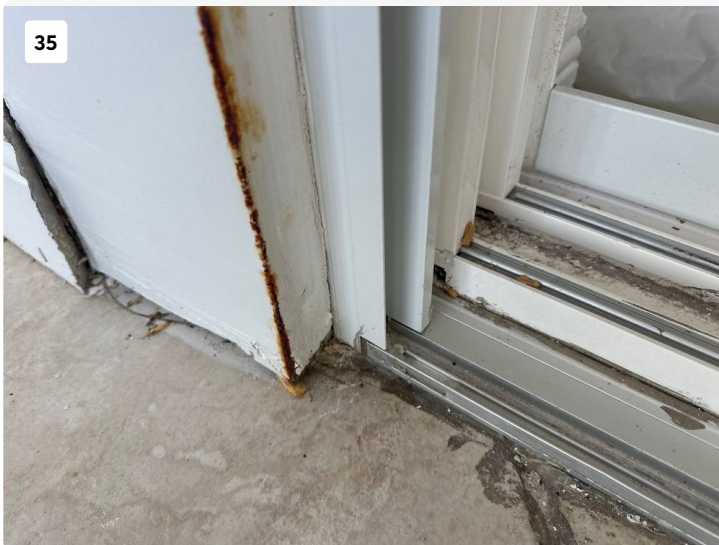
Base of slider and base of wall unsealed.

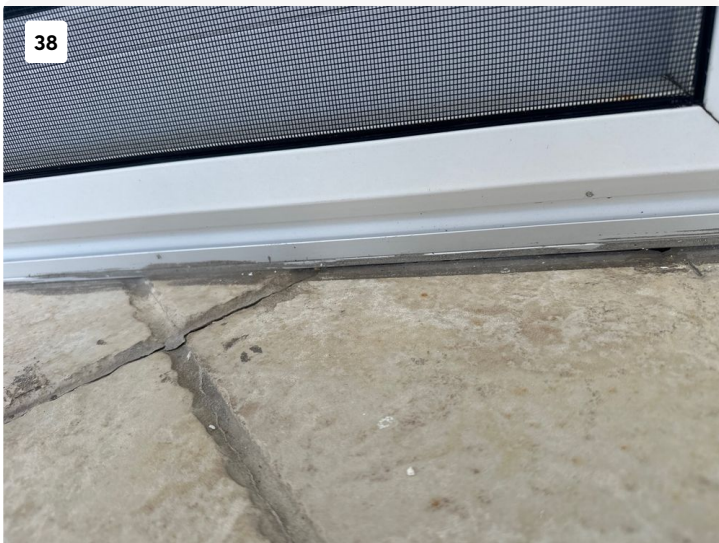
Cracks in tile and deterioration of sealant along base of slider.

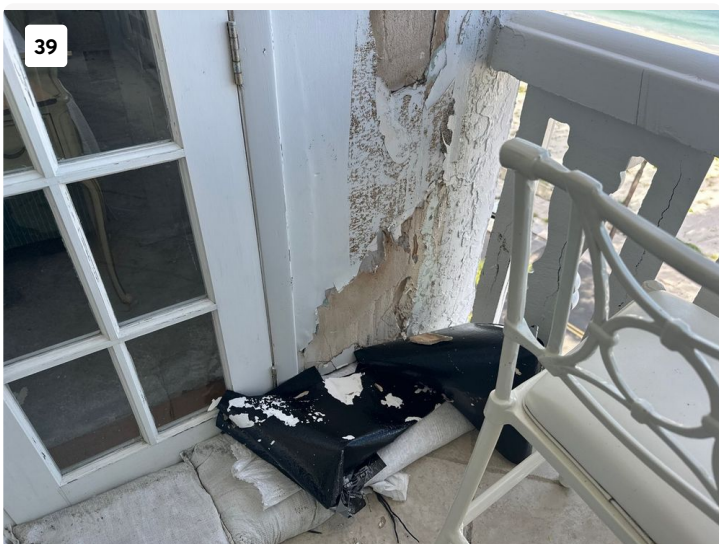
Wall of balcony had widespread deterioration present. Found to have drywall glued to exterior wall and was crumbling.

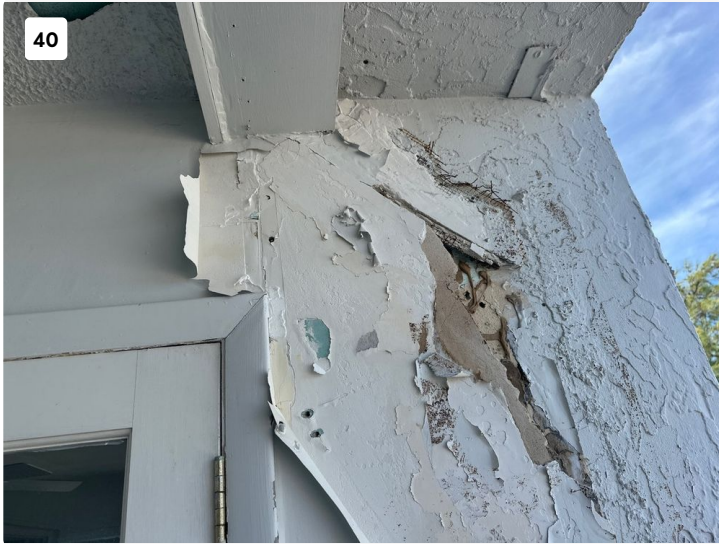
Wall of balcony had widespread deterioration present. Found to have drywall glued to exterior wall and was crumbling.

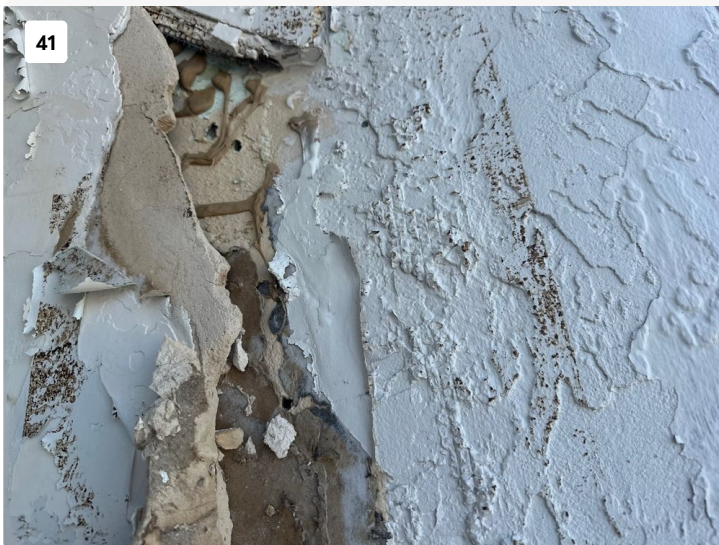
Wall of balcony had widespread deterioration present. Found to have drywall glued to exterior wall and was crumbling.

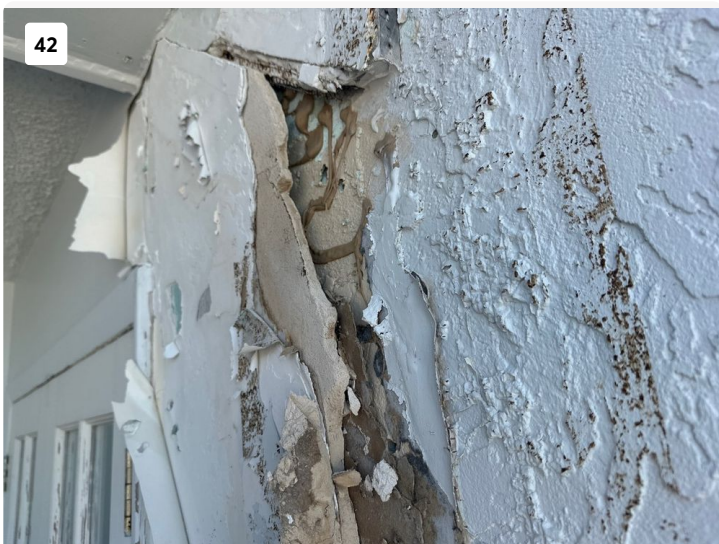
Wall of balcony had widespread deterioration present. Found to have drywall glued to exterior wall and was crumbling.

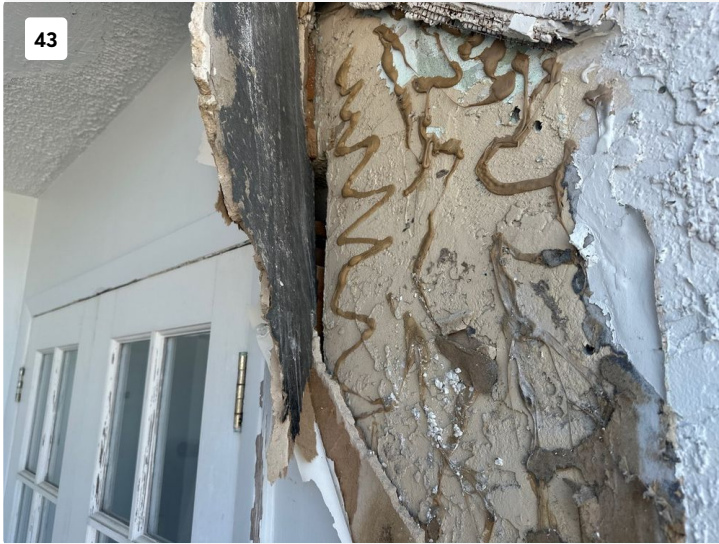
Wall of balcony had widespread deterioration present. Found to have drywall glued to exterior wall and was crumbling.

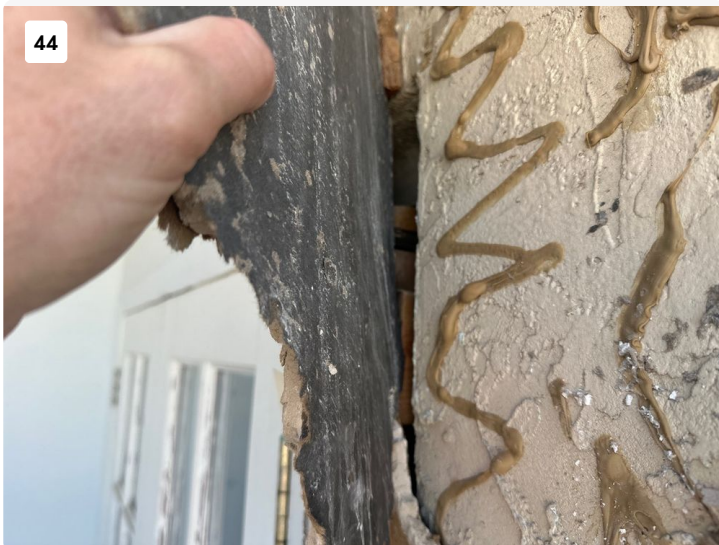
Opening for french door found to be open and not flashed.
