August 27, 2025

RE: *Beach House of Pass-A-Grille Condominium, Inc.*  
*403 Gulf Way*  
*St. Pete Beach, Florida 33706*  
*KEG File #24RP-0314: Milestone Inspection*

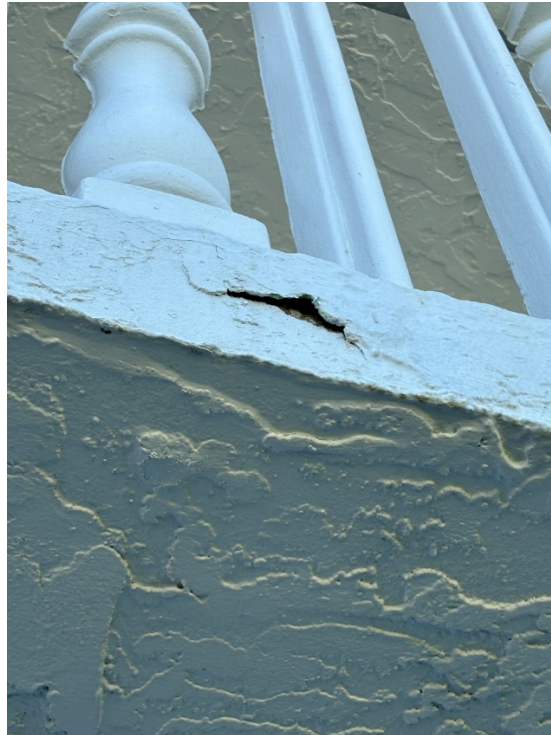
Visible Spall at Slab Edge of Unit 204 from Ground

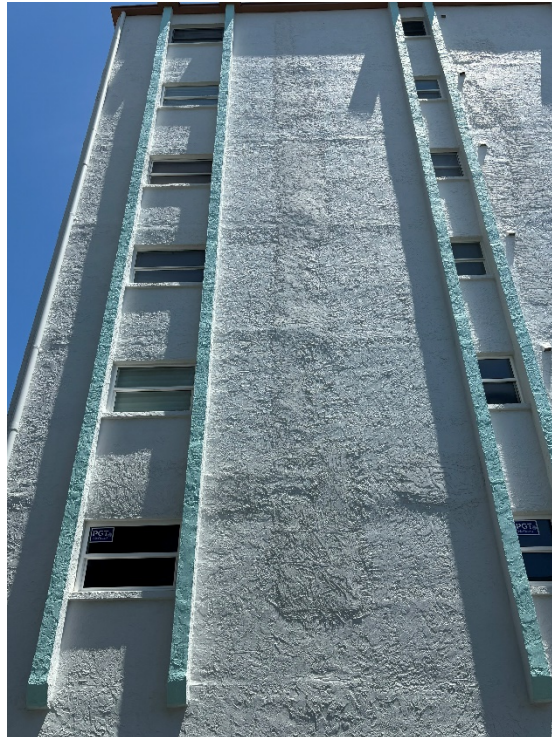
Stucco Repairs Visible at South Elevation of Building

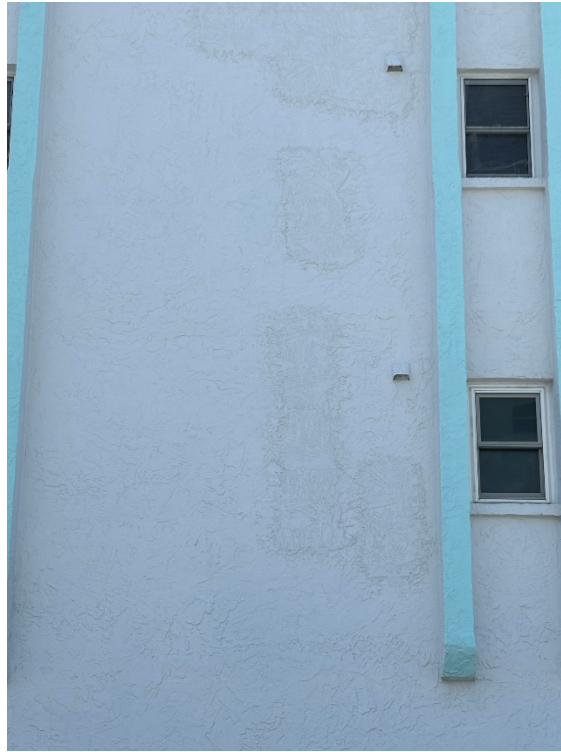
Stucco Repairs Visible at North Elevation of Building

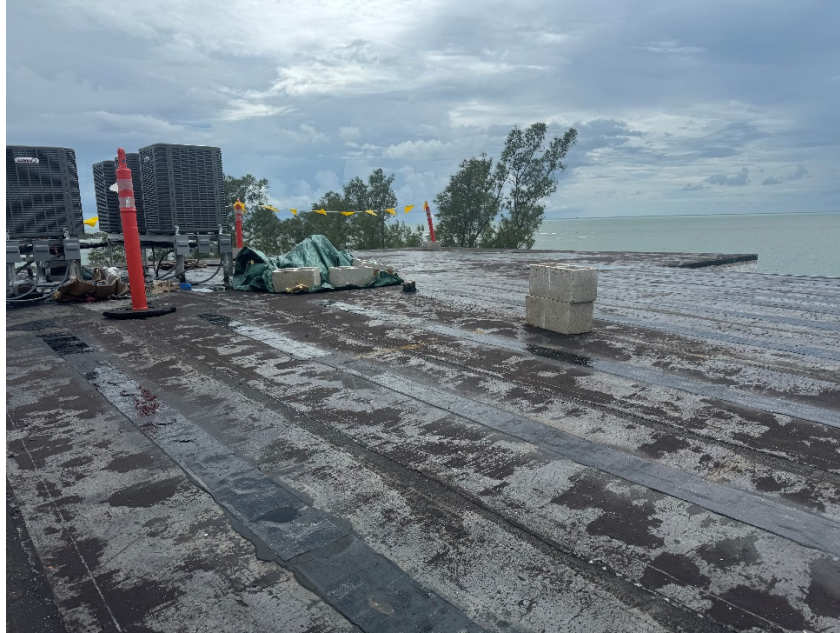
The roof is under construction to install a brand-new roof. The roofing contract is with McMullen Roofing, Inc. and the Engineer is Prescott Engineering, LLC to install a Soprema modified bitumen system. The permit number with the City of St Pete Beach is #2505486 and dated 7/3/2025.

Roof Replacement in Progress with Dry-In Layer Currently in Place

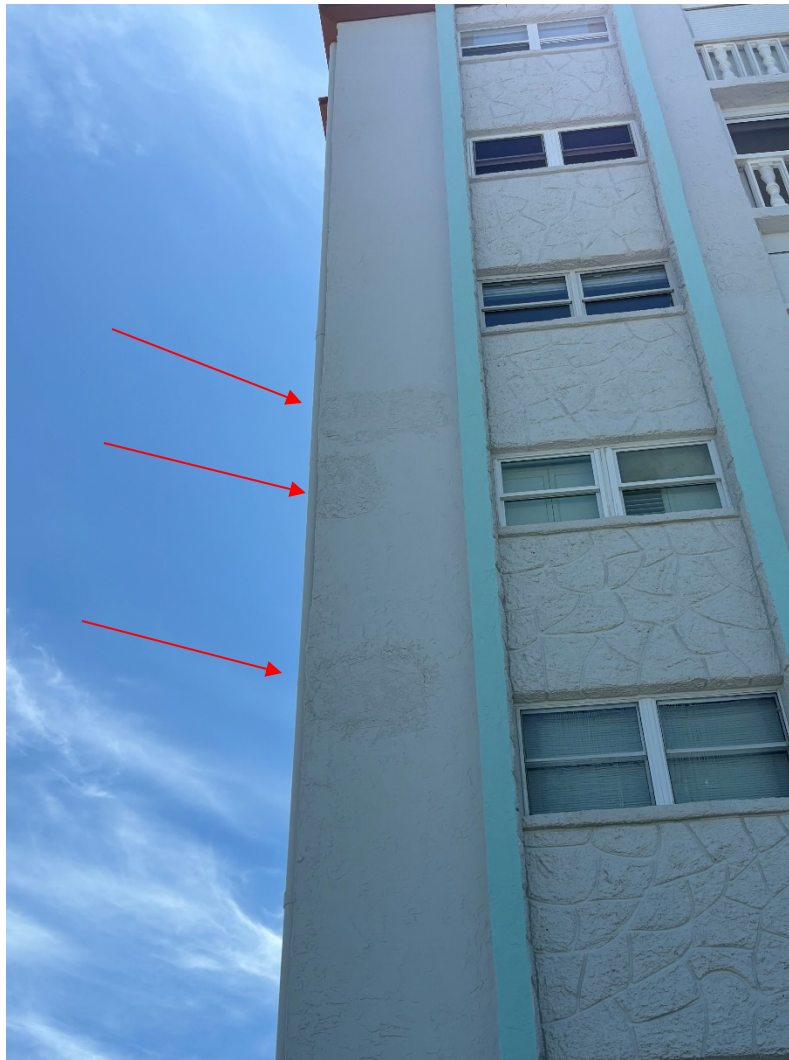
Stucco Repairs to Exterior Walls at Front Elevation of Building

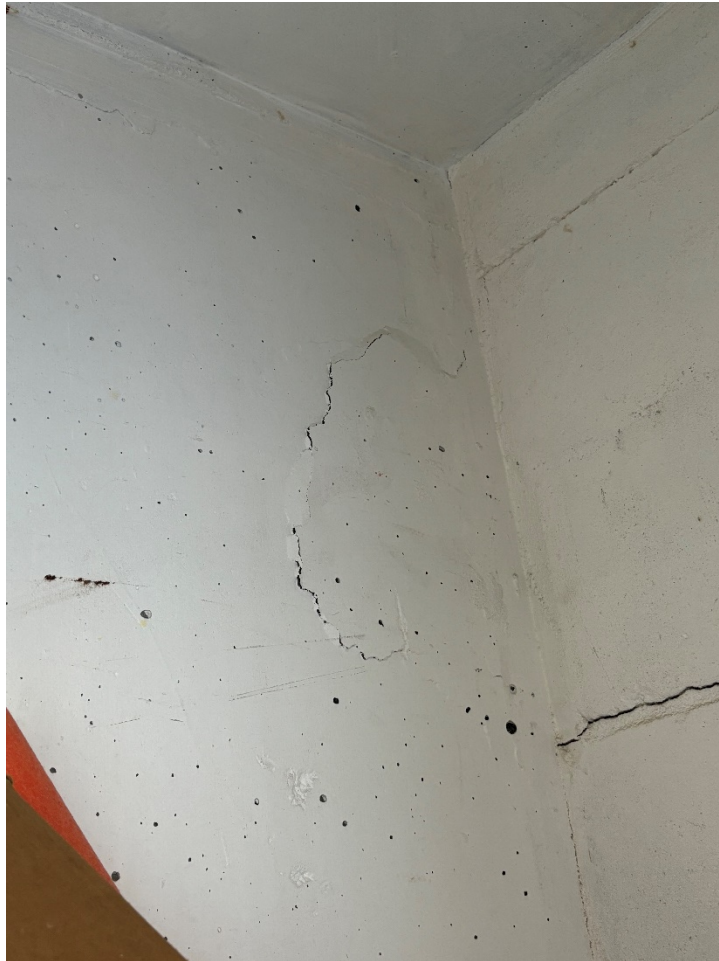
Isolated Spall to Concrete Column Unit 503 Balcony Closet

The bearing walls and structural systems appeared to be in generally fair to good condition. According to the Association, stucco repairs to the exterior walls have been ongoing for the last 5 years. The construction of the bearing walls and structural systems consist of conventional reinforced concrete slabs spanning between reinforced concrete columns and beams. The exterior walls are made up of concrete masonry units with a painted stucco finish. While inspecting the balcony closets, KEG identified a visible isolated spall at the concrete column for unit 503. KEG would recommend performing concrete repairs that follow proper ICRI guidelines to the affected area.

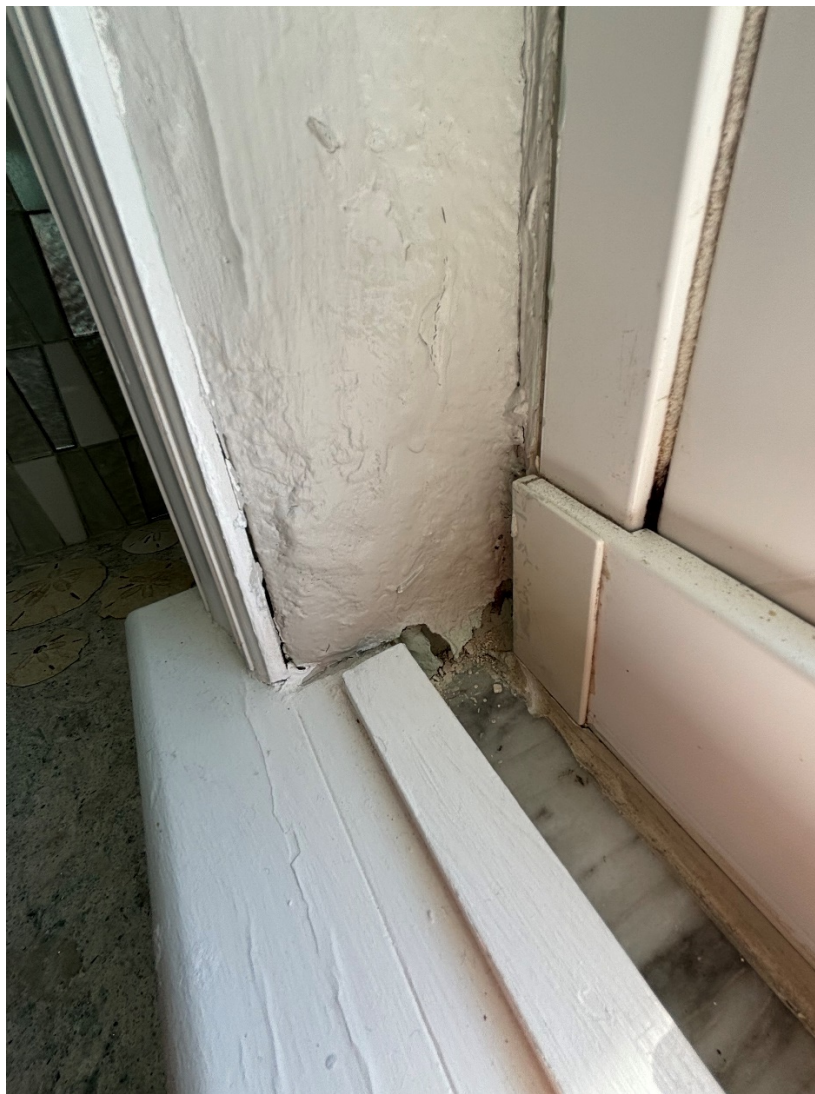
While observing the windows at Unit 301, KEG noted minor water damage to the drywall in the kitchen. The water damage appeared to be old, however KEG would recommend the Association to monitor the area for active water leaks during high wind driven rain or storms that move through the area.

Water Damage at Kitchen Window Unit 301

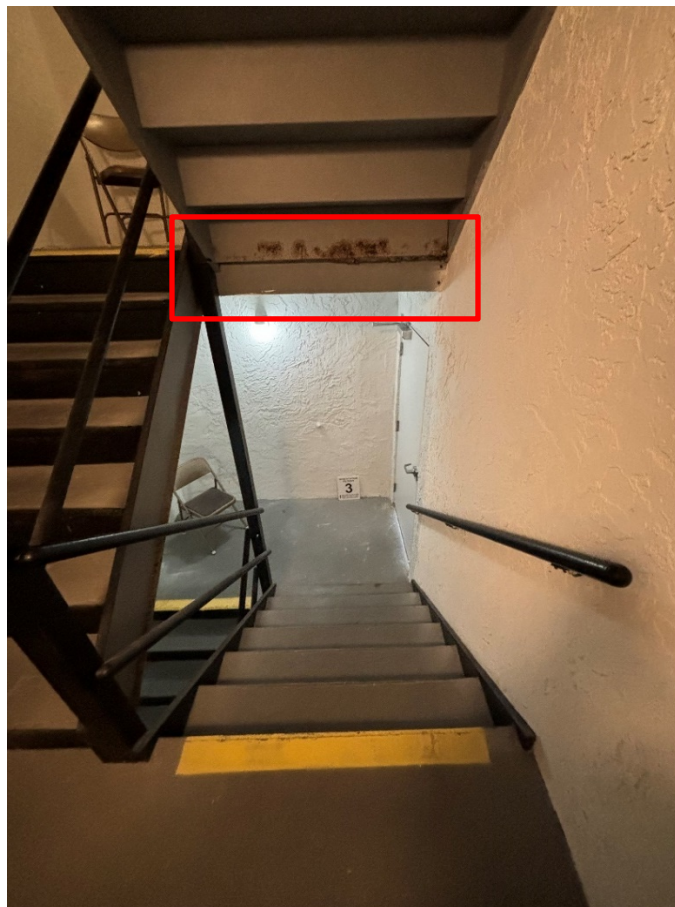
While inspecting the stairwells at the north stairwells, KEG noted deterioration to the lower landing steel pan on the 5<sup>th</sup> floor. The steel stair pan showed signs of rusting and minor section loss of the material. KEG would recommend the replacement of the deteriorating concrete filled steel pan at the identified stairwell. If repairs are not made in a timely matter, the condition could worsen and cause a trip hazard for tenants using the stairwell.

Deteriorating Concrete Steel Pan Identified in North Stairwell

KEG noted the stairwells to be in generally good condition. No signs of structural distress were observed at the time of the inspection. However, KEG noted deterioration of the steel pan on the 5<sup>th</sup> floor causing the material to break down with rusting and minor section loss. KEG would recommend the replacement of the deteriorating concrete filled steel pan at the identified stairwell. If repairs are not made in a timely matter, the condition could worsen and cause a trip hazard for tenants using the stairwell.

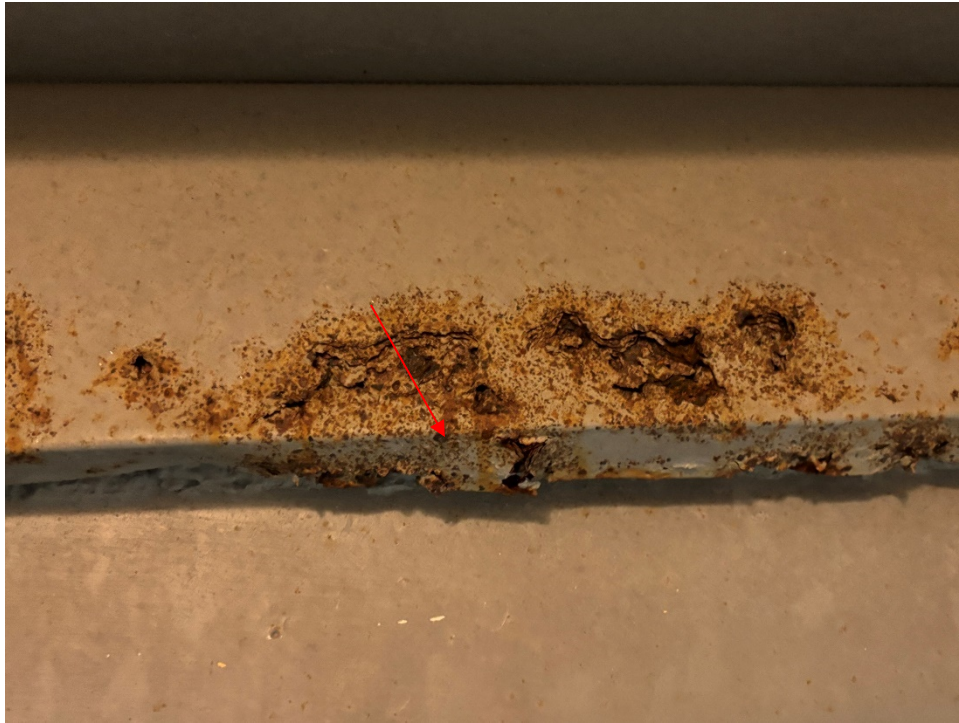
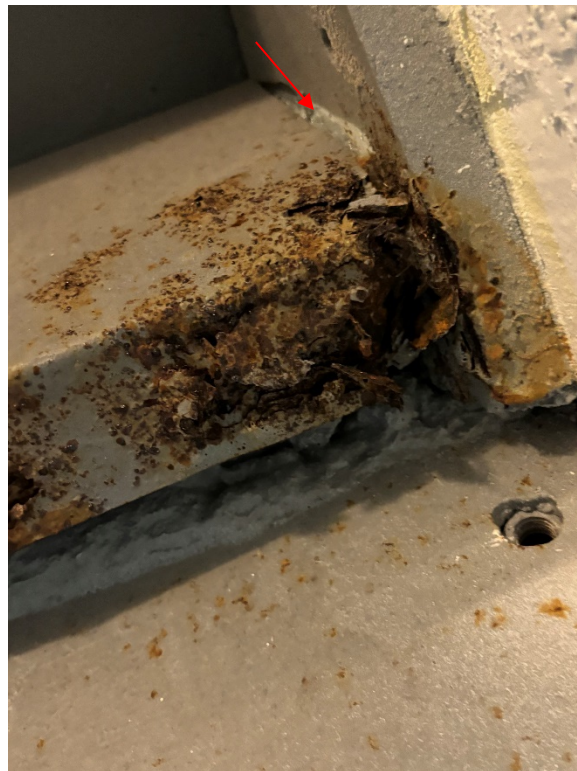
Observed Rusting and Minor Section Loss for Identified Concrete Filled Steel Pan

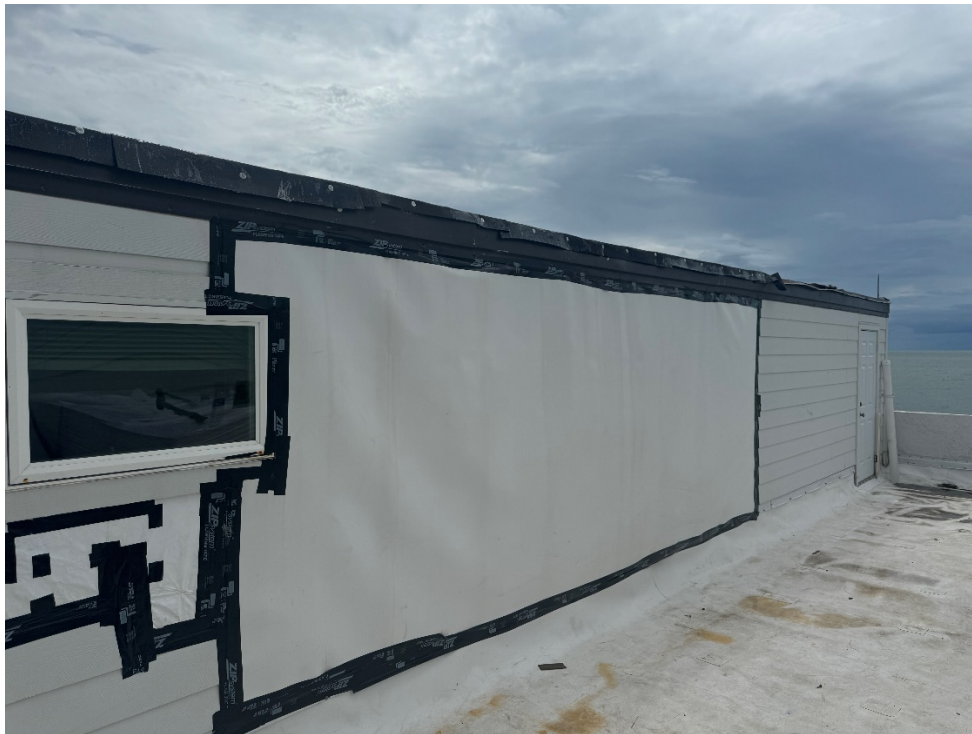
The Association has a current contract with WKM Restoration Group for work to reconstruct the exterior walls of Unit 701 and 704 to address the previous leaks. Prescott Engineering is the design engineer for the exterior walls and permit #2505502 is currently under review by the City of St Pete Beach.

Exterior Frame Wall Reconstruction in Progress

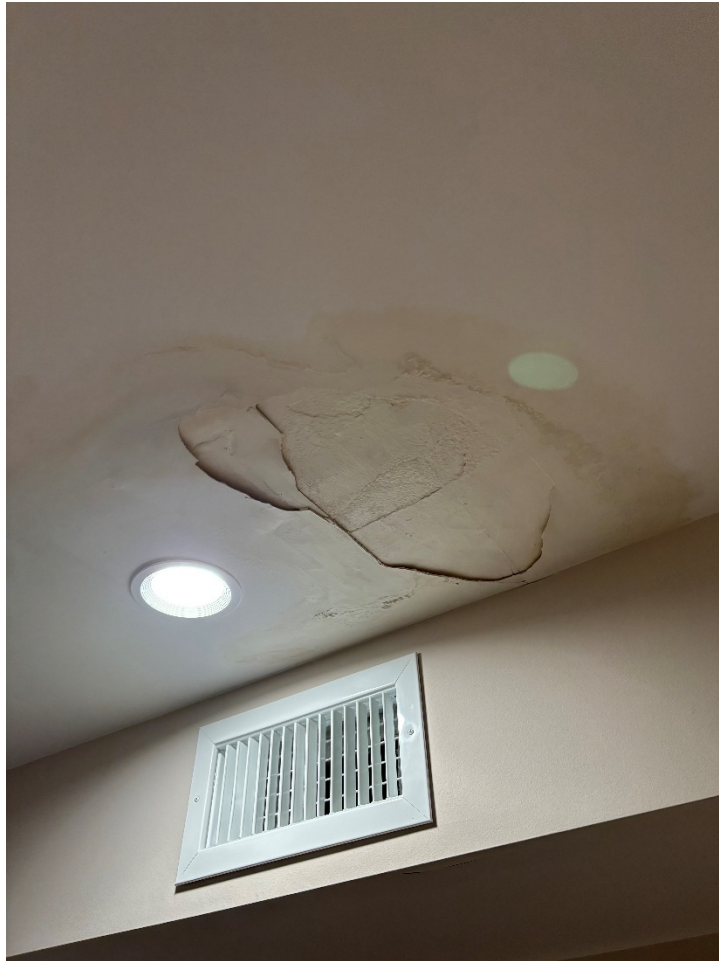
Water Damage at Ceiling of Unit 704

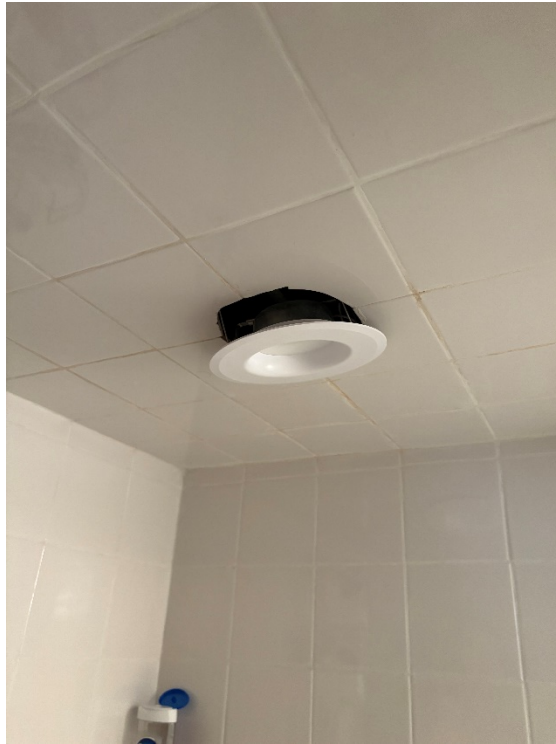
Unit Owners in Unit 603 Stated Water Leaks Occurring in Bathroom

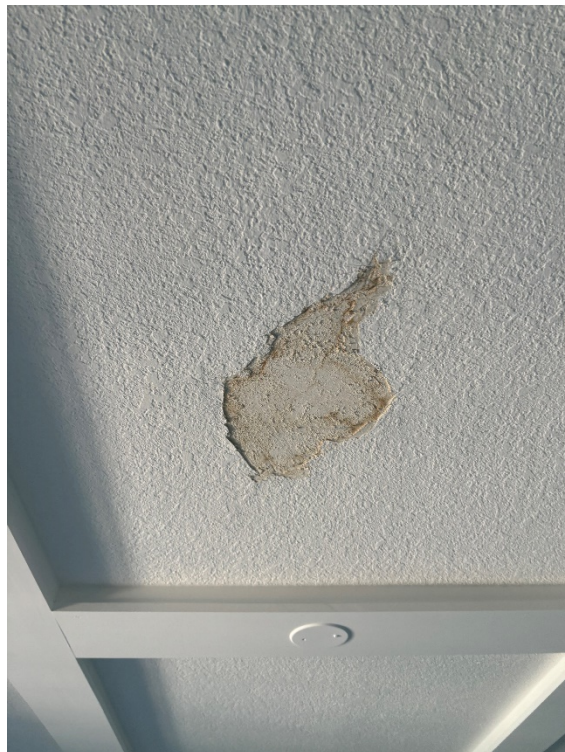
Water Damage in Ceiling of Master Bedroom Unit 602

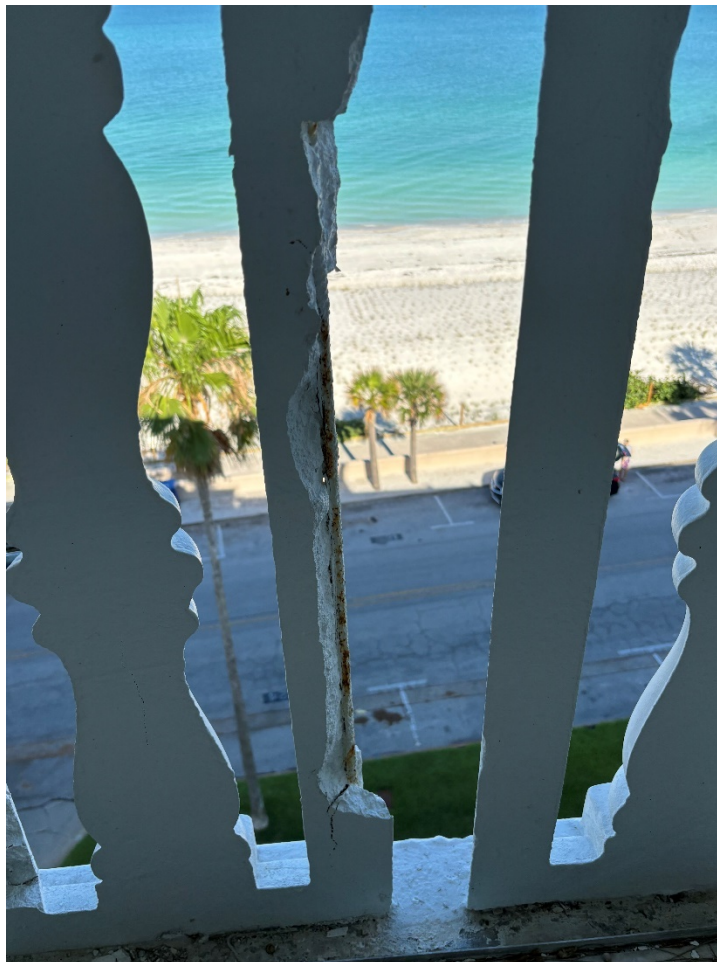
While inspecting the balconies, KEG noted numerous concrete guardrails appeared to be cracking, including exposed reinforcement at Unit 701. The constant exposure to the harsh Florida environment and lack of maintenance for the concrete guardrail are likely creating the cracks and spalls. Over time, without maintenance for the concrete guardrails, the material will spall and potentially fall off the balconies creating a hazard for tenants or pedestrians. KEG would recommend performing concrete repairs to the identified concrete guardrails. KEG would also recommend applying a penetrating concrete sealer for the guardrails to help prolong the life of the material.

Exposed Reinforcement at Concrete Guardrail Unit 701

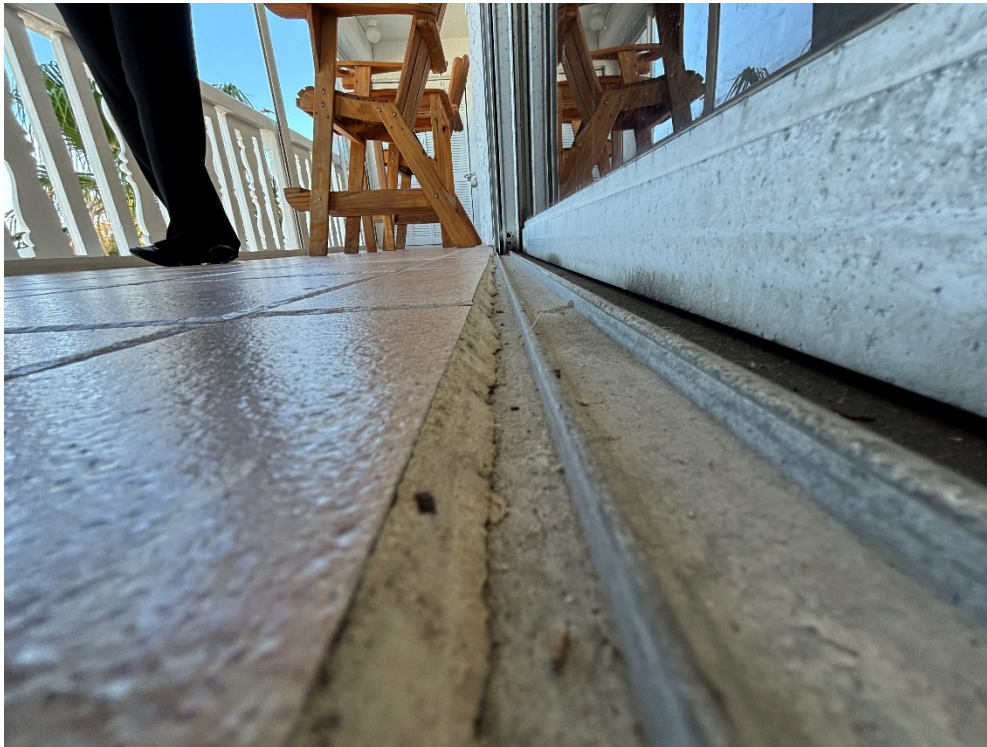
KEG noted the older sliding glass doors appeared to have thresholds level or below the tiled finishes with rusting or deteriorating fasteners. Thresholds that are below or level with the tiled finishes are suspect areas of water intrusion due to not allowing moisture to exit the area properly. The deterioration of the fasteners potentially could allow moisture to enter the building from the sliding glass door thresholds. If the unit owners are not replacing the sliding glass doors, KEG would recommend replacing deteriorating fasteners by wet setting new stainless-steel fasteners with a waterproofing sealant to help minimize the chances of moisture to enter into the building and units below.

Sliding Glass Door Threshold Below Tile Finish Unit 502

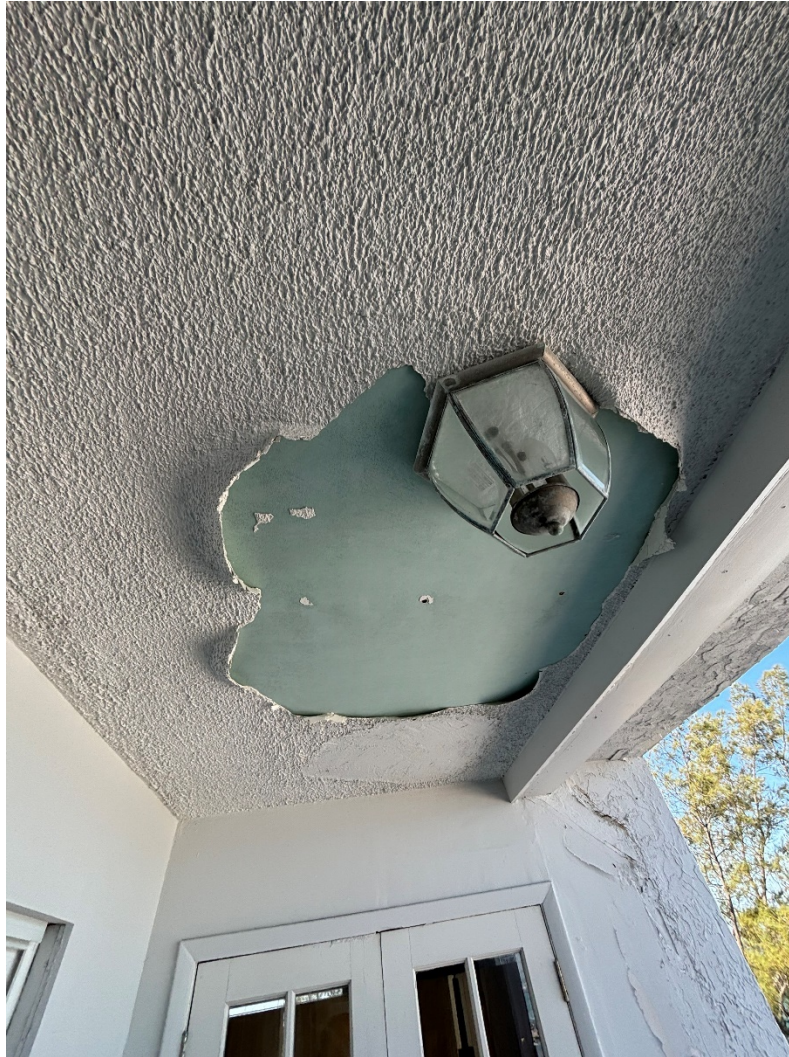
KEG noted Unit 701 appeared to have failing sealants at the wooden joists and sliding glass doors, damaged coping caps on top of the frame wall and damaged tile adjacent to the balcony door at the open balcony; Additionally for Unit 701, KEG noted visible damage to the ceiling finish, and other damages to balcony components that potentially could be areas for moisture to enter at the enclosed balcony. Unit 704 appeared to have a void in the frame wall underneath the roof gutter where moisture is likely entering this area. As previously stated in the water intrusion report provided by Karins Engineering, KEG would recommend the remediation of the frames walls and be rebuilt to conform to current FBC standards, including providing proper waterproofing measures to minimize moisture from entering at these areas. KEG would also recommend performing repairs to the identified damaged areas on the enclosed balcony for Unit 701.

Damaged Ceiling Finish Unit 701

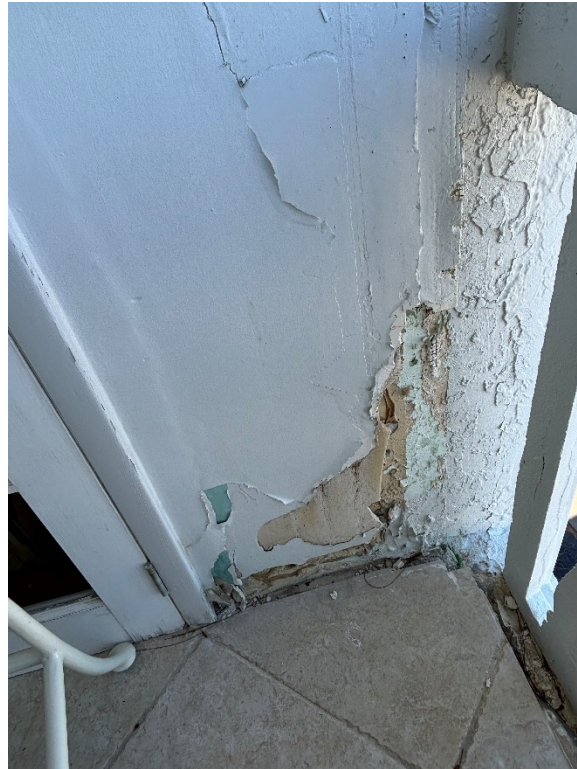
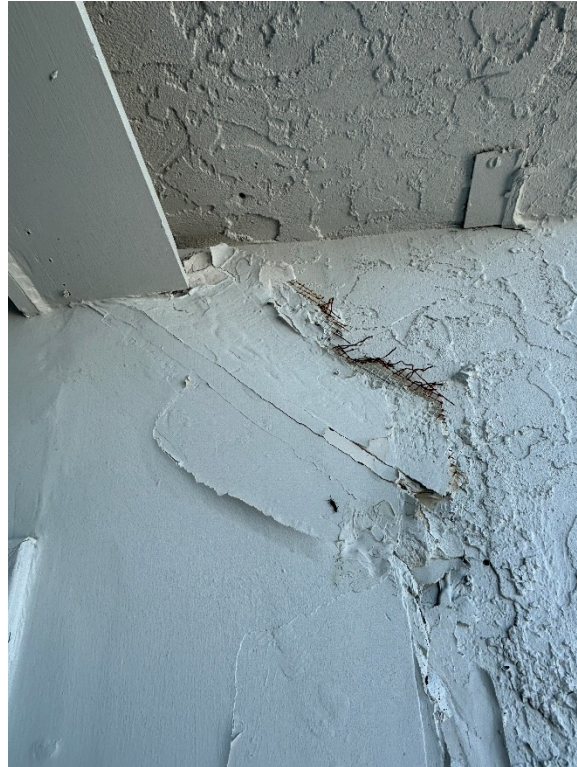
Damaged Balcony Component Unit 701

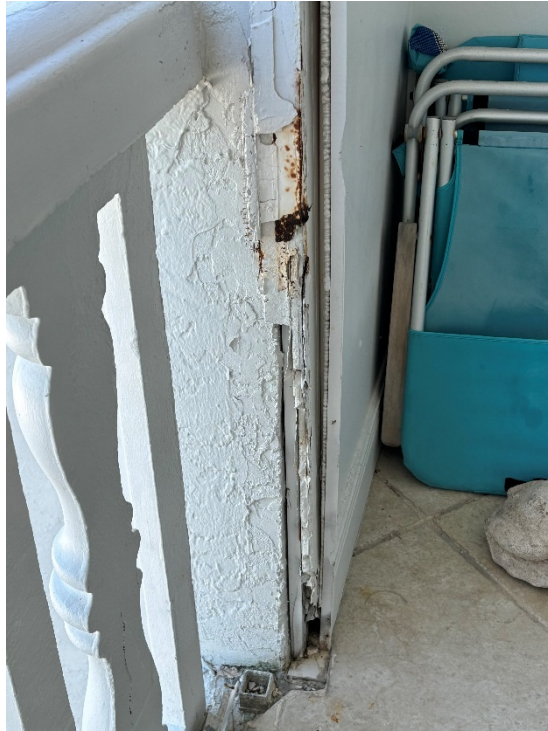
Additional Damage at Balcony Unit 701

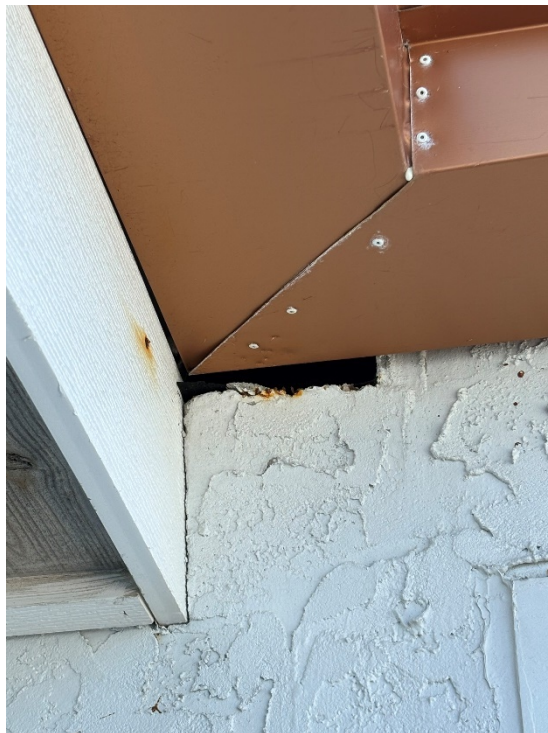
Void at Unit 704 Balcony Wall

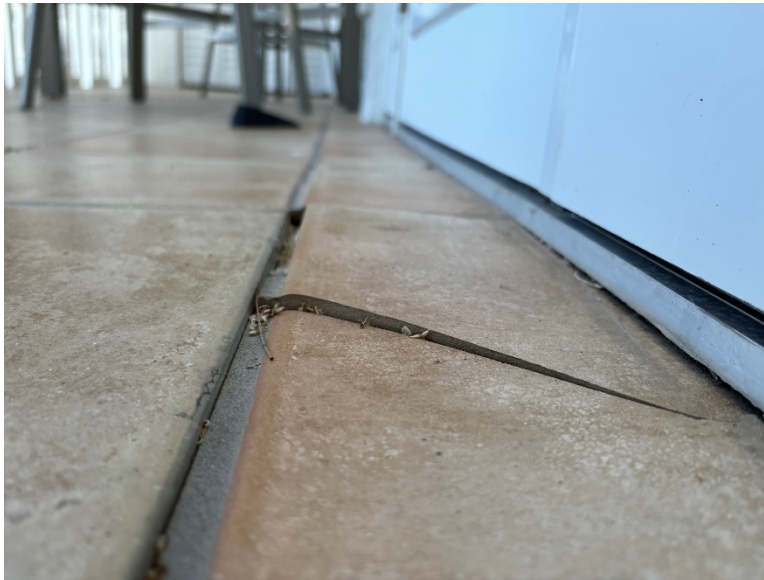
KEG noted damaged tiles that appeared to be tenting and hollow at Units 402 and 203. Due to the tiled finishes, KEG was unable to observe the concrete substrate. However, it is likely the concrete beneath the tile is spalling and creating the tenting affect on the tiles. KEG would recommend the removal of the tiled finishes as they are susceptible to holding moisture if maintenance to the tiles is not performed routinely. KEG would also recommend the Association to further investigate installing a polyurethane waterproofing membrane or cementitious waterproofing system if the tiles are removed from the balconies.

Damaged Tile at Balcony Door Threshold Unit 402

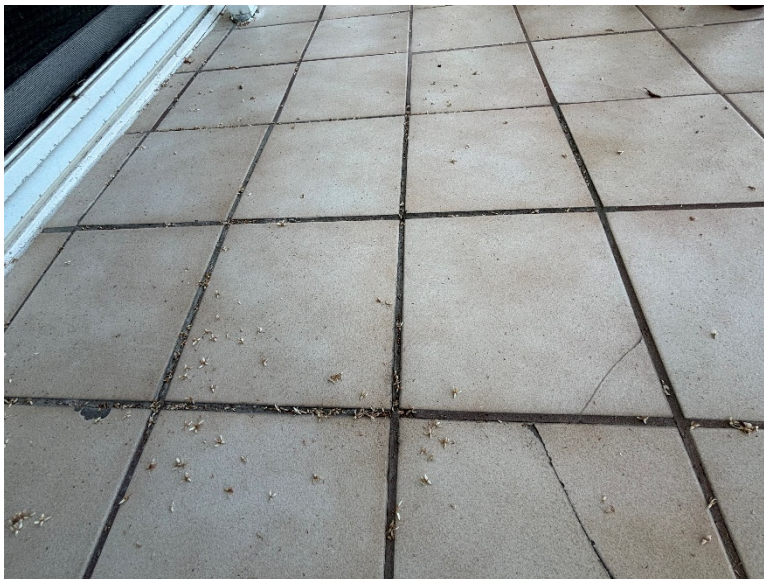
Area of Tenting Tile/ Hollow at Balcony Unit 203

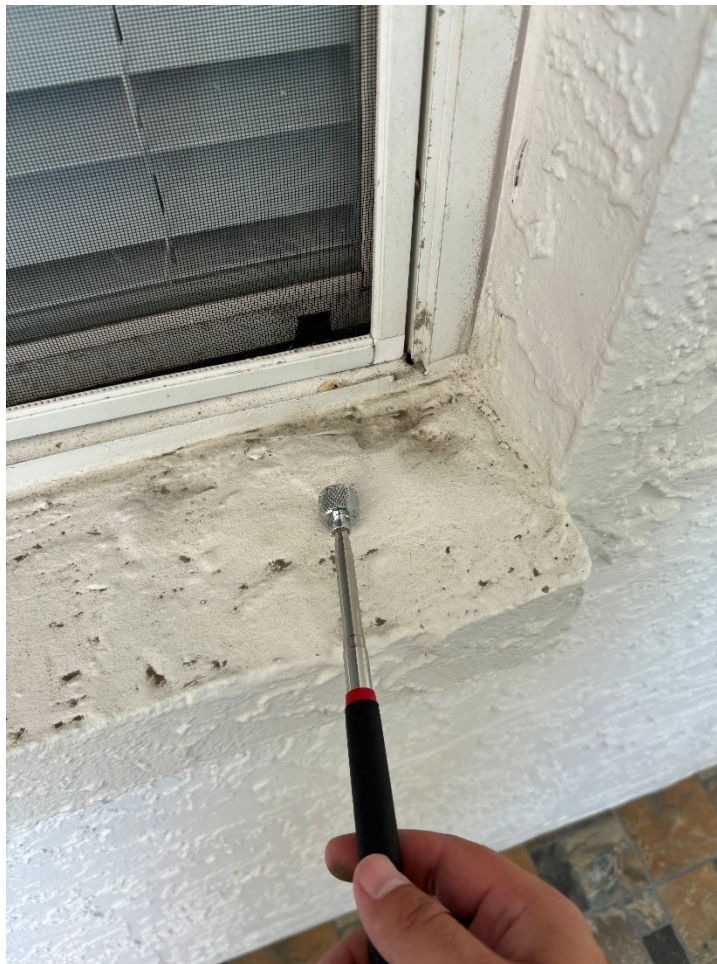
Minor Isolated Spall Identified on Third Floor Walkway, Unit 302

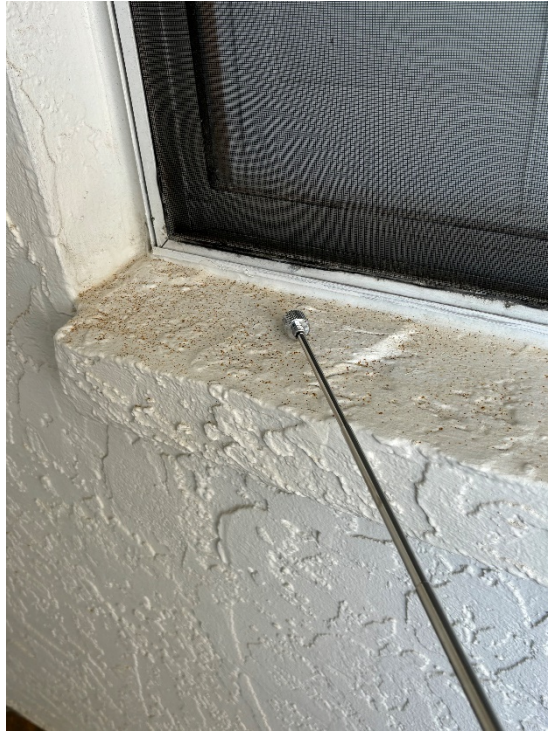
Minor Isolated Spall Identified on Sixth Floor Walkway, Unit 602

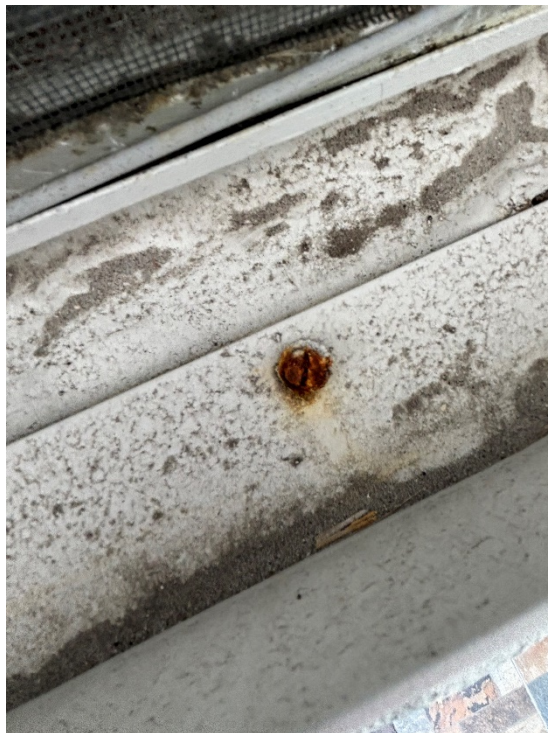
Rusting Fasteners at Identified Exterior Window Sills with Shutters

KEG noted the walkways to be in generally good condition. However, KEG noted on the 6<sup>th</sup> and 3<sup>rd</sup> floor walkways, Unit 602 and 302 exterior concrete windowsills appeared to have minor isolated spalls. Additionally, KEG noted windows on the walkways that have hurricane shutters installed appeared to have rusting and deteriorating fasteners embedded in the concrete windowsills. KEG would recommend performing concrete repairs to the identified window sills during the next building envelope project, including removing the deteriorating fasteners from the storm shutters and wet setting new stainless steel fasteners with a waterproofing sealant.

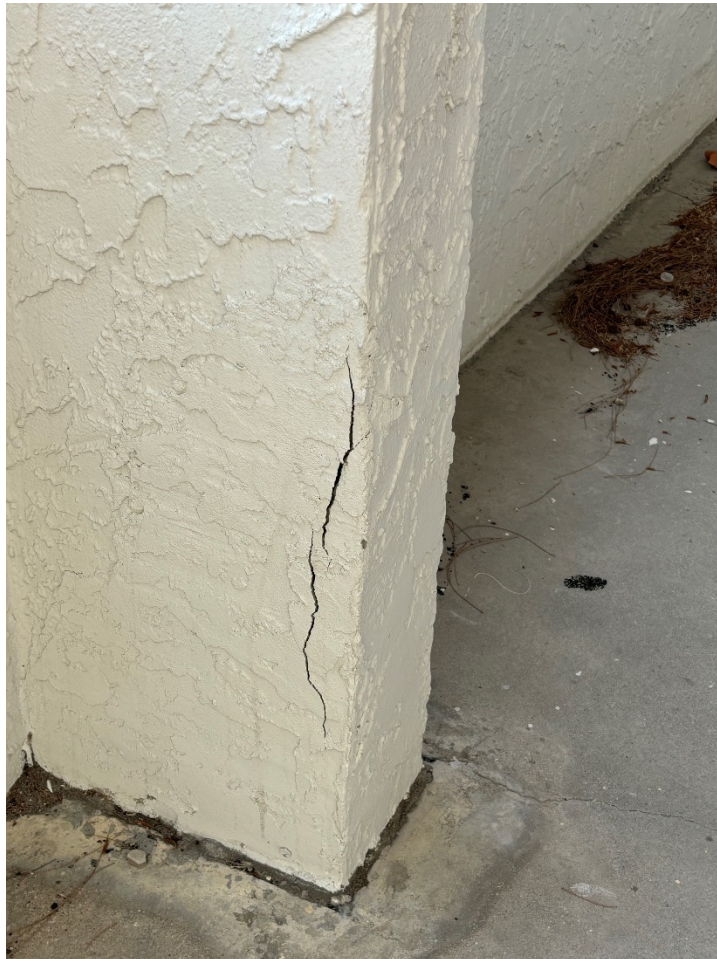
While inspecting the parking garages, KEG observed multiple columns in both the north and south garage appearing to be cracking. KEG utilized a mechanical sounding tool to sound out the areas cracking to determine if there were sounds of hollowness in the stucco or concrete. After using the mechanical tool, KEG identified areas of hollowness where the cracking was occurring. Typically, with hollow sounding concrete there is an isolated spall occurring where the material is breaking down, allowing moisture to penetrate the steel reinforcement. Once the steel is exposed to the Gulf salt laden air and water, the steel begins to oxidize. The oxidation of the steel causes rusting and expanding while embedded in the concrete, over time this leads the concrete to break down and spall. KEG would recommend performing concrete repairs to the identified columns by following proper ICRI guidelines. All repairs to load bearing structural components should be reviewed by the current EOR for shoring and repairs.

Visual Crack Forming at Column of North Parking Garage

sounding tool, potentially spalls are occurring at the identified columns. KEG would recommend performing concrete repairs to the identified columns by following proper ICRI guidelines. All repairs to load bearing structural components should be reviewed by a EOR for shoring and repairs.

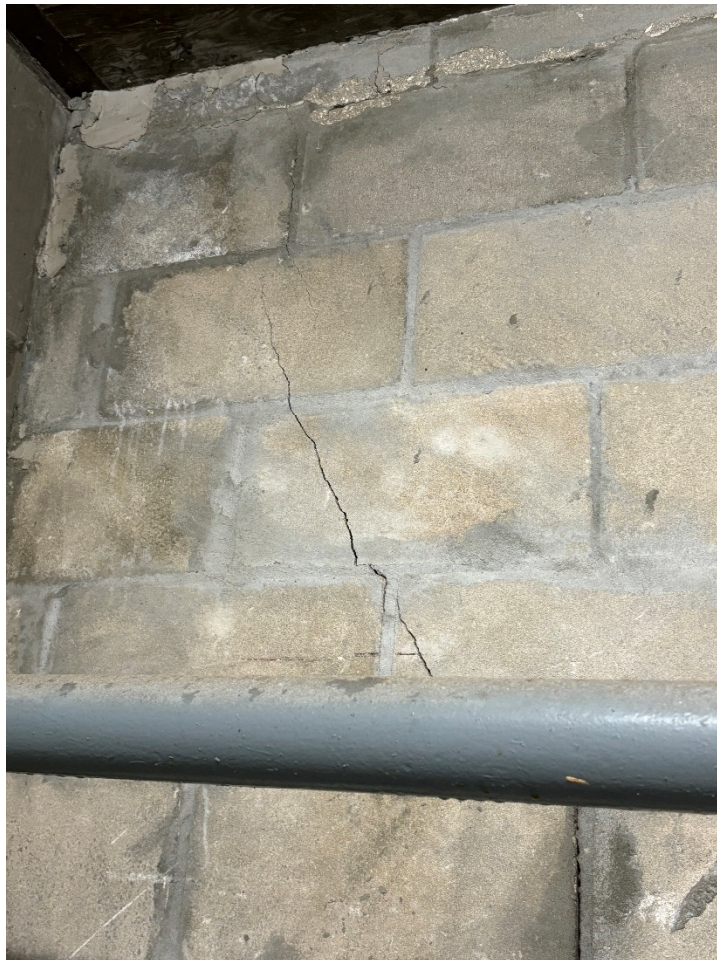
The Beach House contained a rec room, laundry room, storage room for unit owners, FACP room and elevator room. KEG was unable to access an additional electrical room in the south stairwell. KEG noted the MEP and Storage rooms to be in generally good condition. No signs of significant structural distress were observed at the time of the inspection. However, while inspecting the elevator room, KEG noted a crack larger than a hairline formed in the concrete masonry unit wall. The crack is minor but should be addressed during the next building envelope project during the concrete and stucco repairs. KEG would recommend performing crack repairs to the identified area during the next building envelope project.

Crack Formed in Concrete Masonry Wall of Elevator Room

KEG noted MEP and storage rooms to be in generally good condition. However, KEG noted in the elevator room a crack forming in the concrete masonry wall. KEG would recommend performing crack repairs to the identified area during the next building envelope project.
