# Windstorm Mitigation Report

Beach House Of Pass-A-Grille

St. Pete Beach, FL

As of 8/8/2023 | FPAT File# MIT2320596

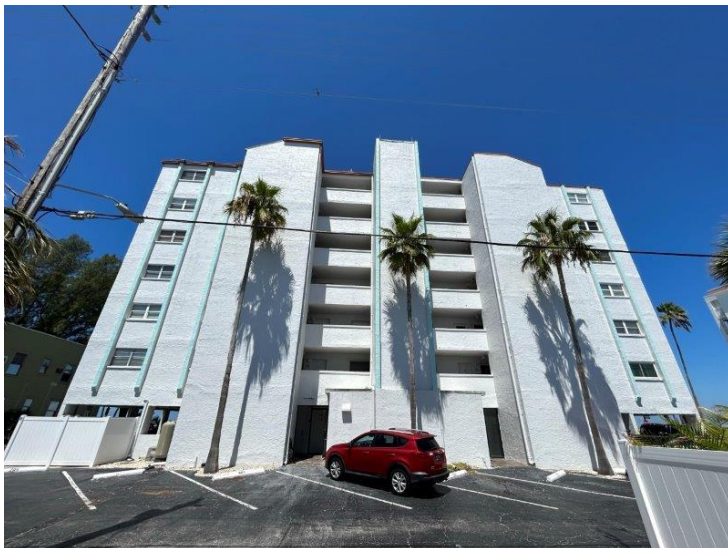
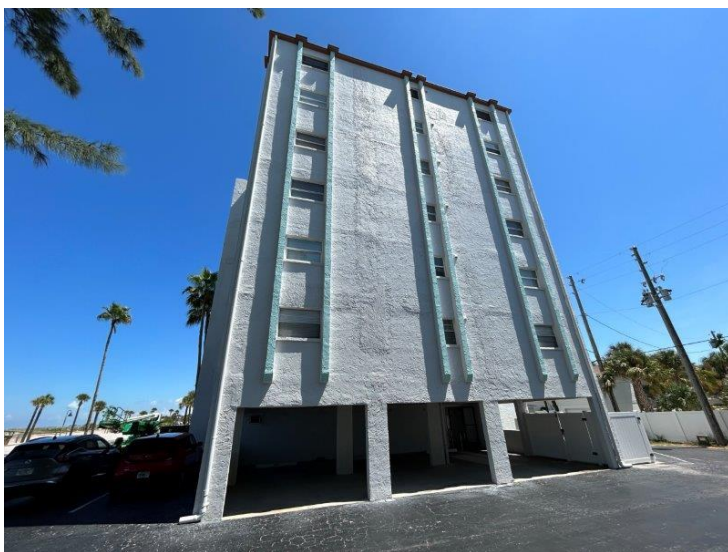
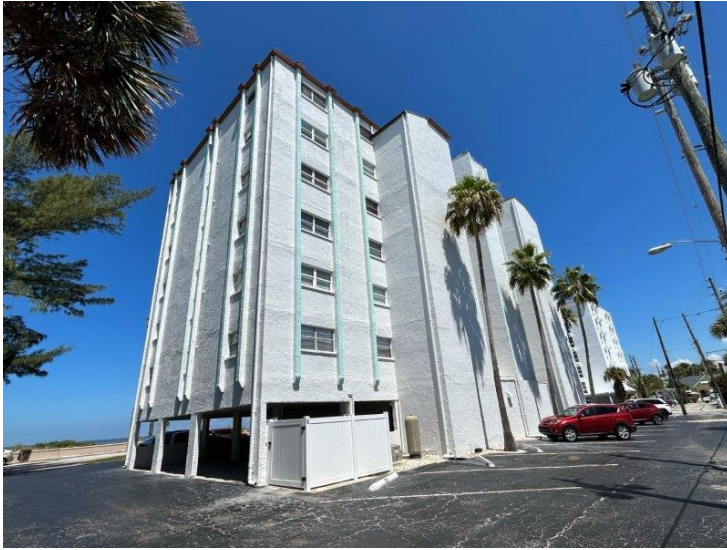
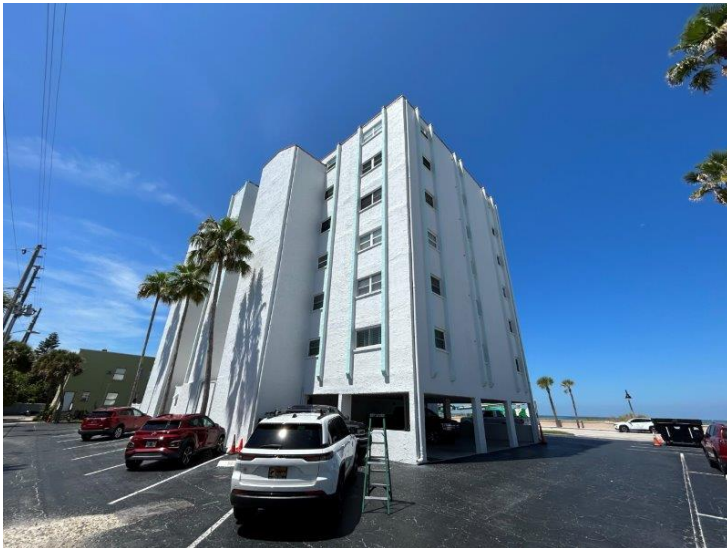
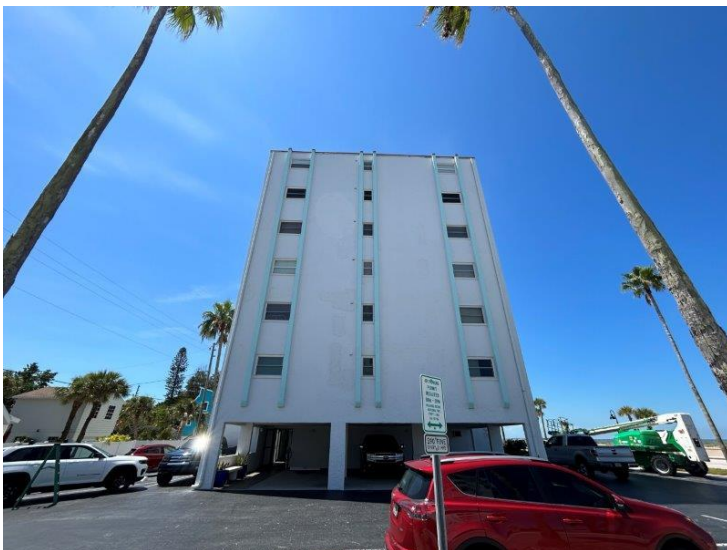
Exterior Elevation

| <b>5. Roof Geometry:</b><br>Comments: | <b>Flat Roof</b><br>Inspection verified flat roof shape, refer to attached photographs. |
| <b>7. Opening Protection:</b><br>Comments: | <b>None or Some Glazed Openings</b><br>No opening protection verified at the time of inspection. |

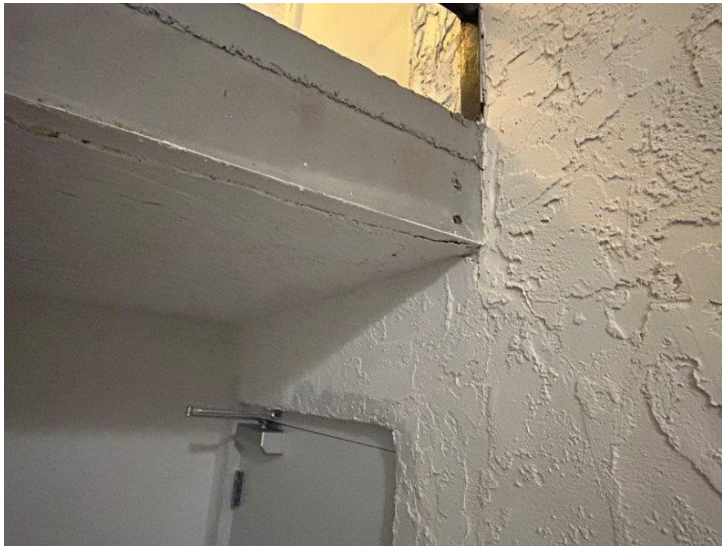
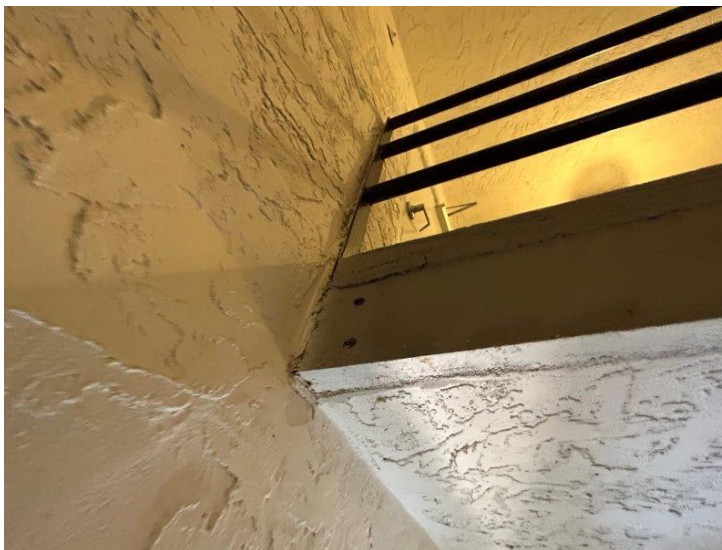
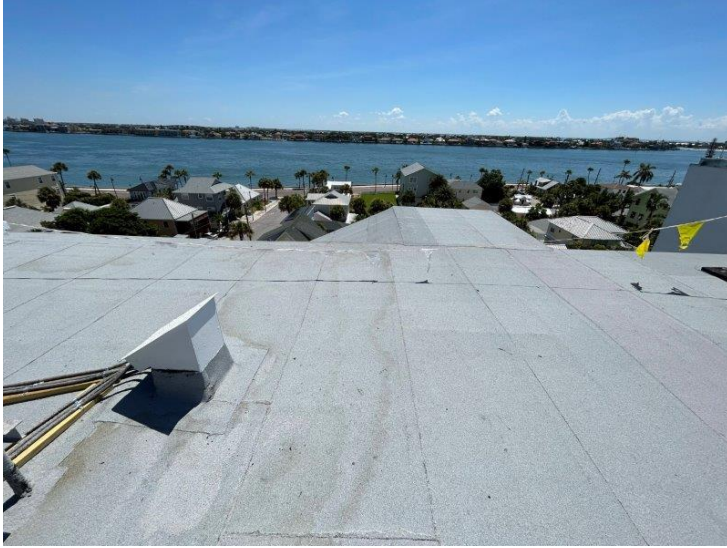
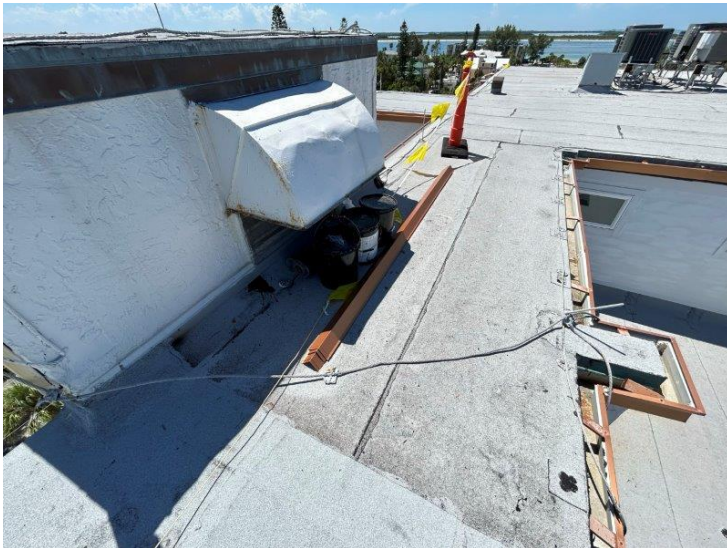
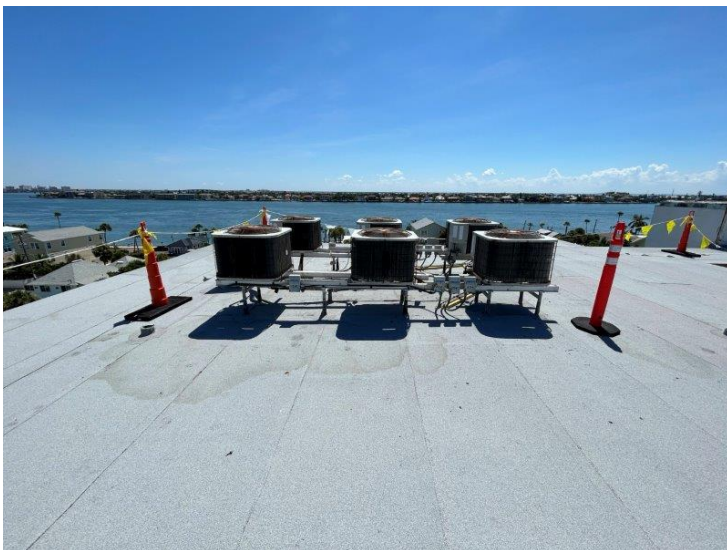
Roof Construction

| <b>2. Roof Covering:</b><br>Comments: | <b>FBC Equivalent</b><br>The roof covering was replaced in 2023. The roof permit was confirmed and the permit number is 2300973. This roof was verified as meeting the building code requirements outlined on the mitigation affidavit. |
| <b>3. Roof Deck Attachment:</b><br>Comments: | <b>Reinforced Concrete Roof Deck</b><br>Inspection verified a roof structure composed of cast-in-place or pre-cast structural concrete designed to be self-supporting and integrally attached to the wall / support system. |
| <b>4. Roof to Wall Attachment:</b><br>Comments: | <b>Structural</b><br>Inspection verified a roof structure composed of cast-in-place or pre-cast structural concrete designed to be self-supporting and integrally attached to the wall / support system. |

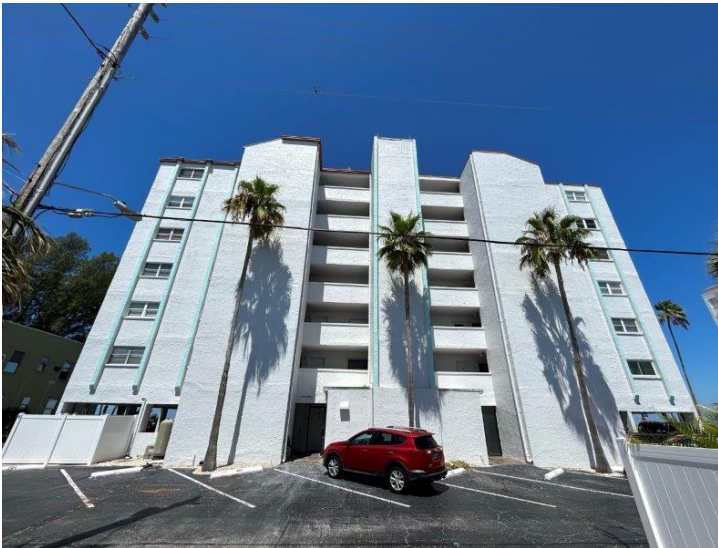
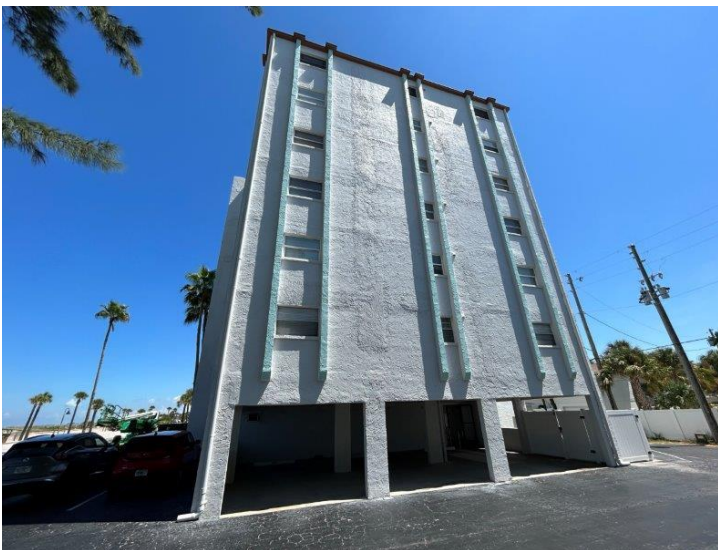
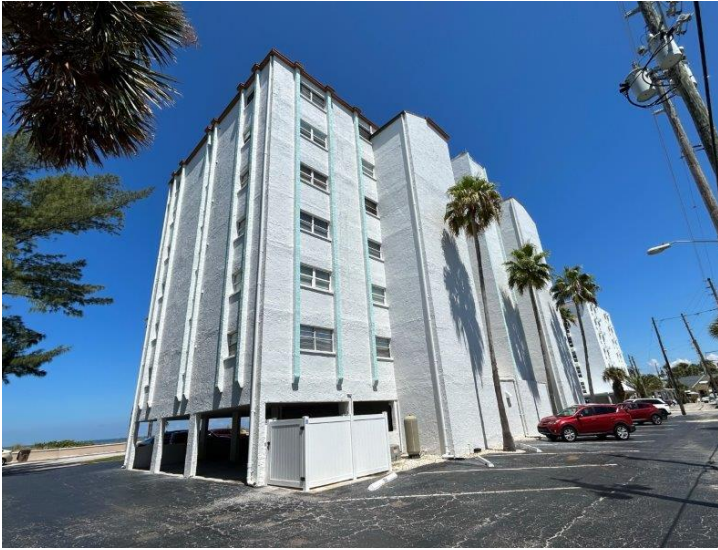
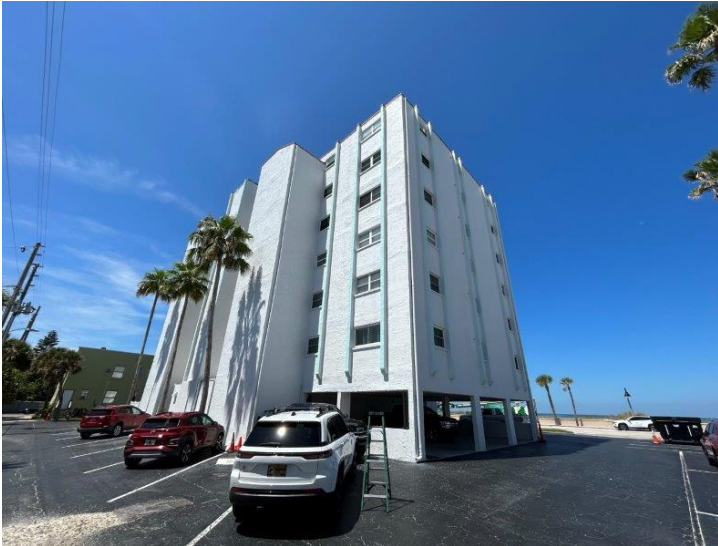
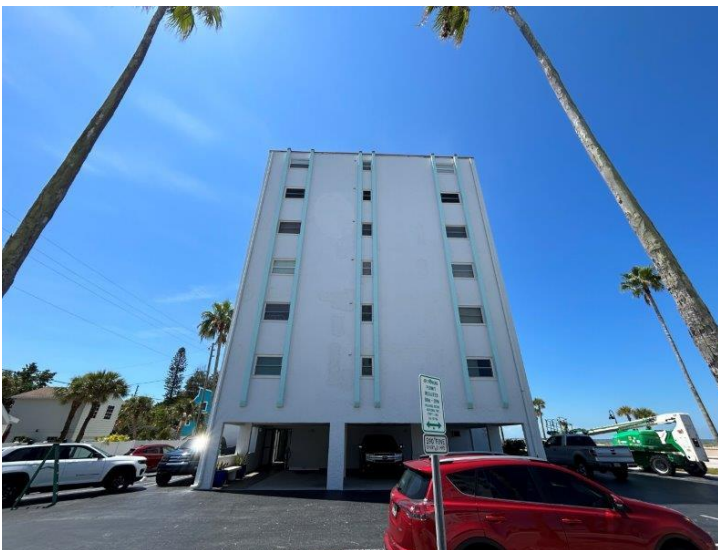
Exterior Elevation

| <b>4. Opening Protection:</b><br>Comments: | <b>None or Some Glazed Openings</b><br>No opening protection verified at the time of inspection. |

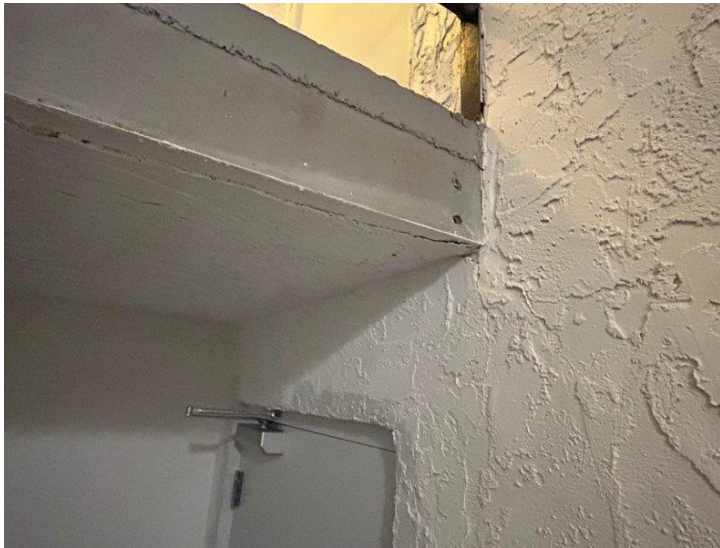
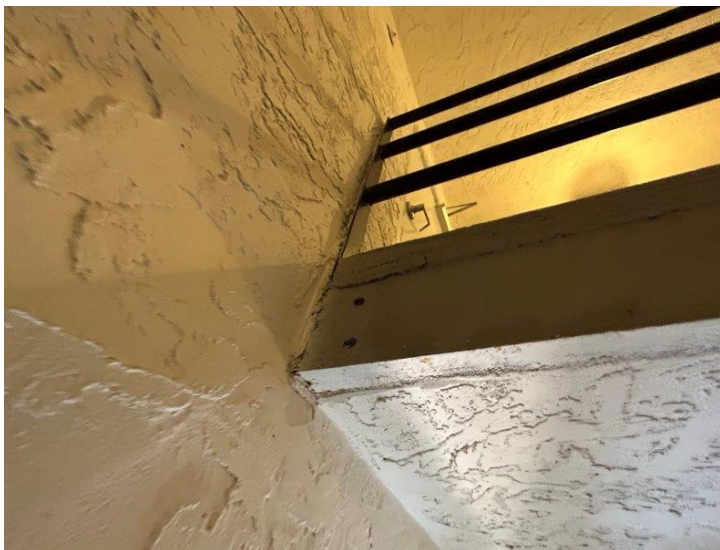
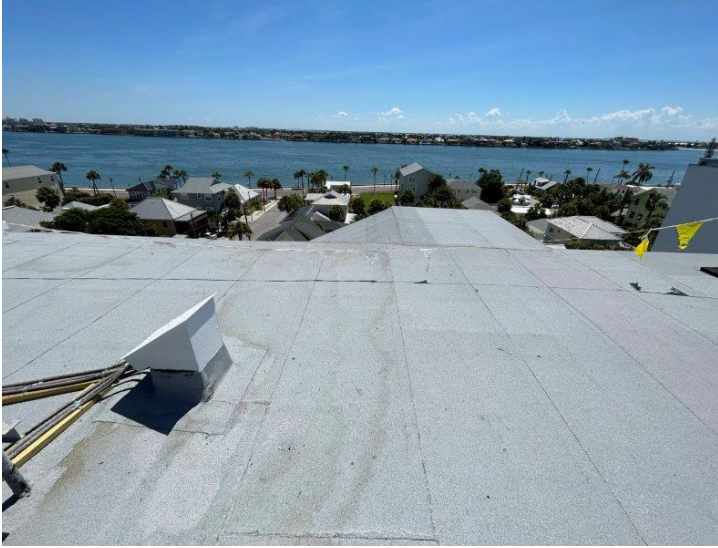
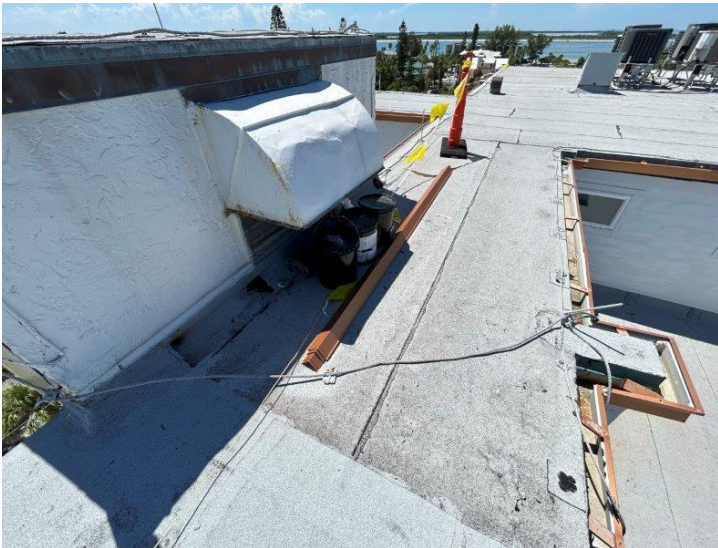
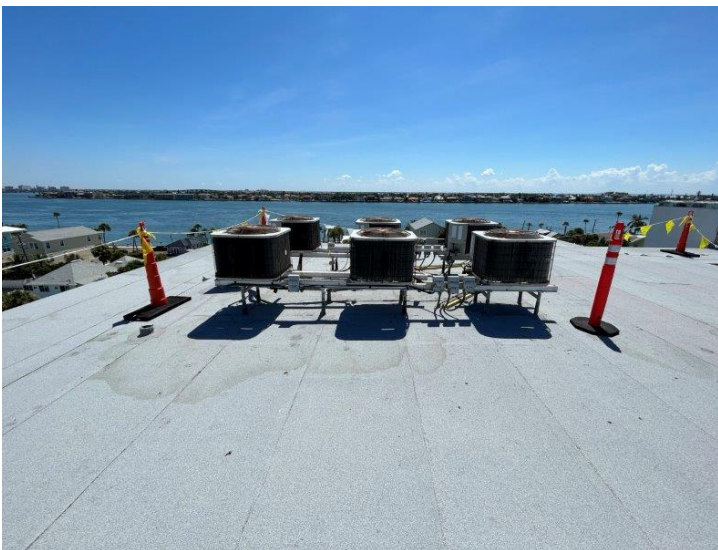
Roof Construction

| <b>1. Roof Covering:</b><br>Comments: | <b>FBC Equivalent</b><br>The roof covering was replaced in 2023. The roof permit was confirmed and the permit number is 2300973. This roof was verified as meeting the building code requirements outlined on the mitigation affidavit. |
| <b>2. Roof Deck Attachment:</b><br>Comments: | <b>Reinforced Concrete Roof Deck</b><br>Inspection verified a roof structure composed of cast-in-place or pre-cast structural concrete designed to be self-supporting and integrally attached to the wall / support system. |
| <b>3. SWR:</b><br>Comments: | <b>No</b><br>SWR does not apply to reinforced concrete roof decks. |
