**Subject: Leak inspection  
Beach House Condominiums  
Pass-A-Grille, Florida**

***Leak Inspection Report  
Beach House Condominiums  
Pass-A-Grille, Florida***

# **Beach House Leak Inspection**

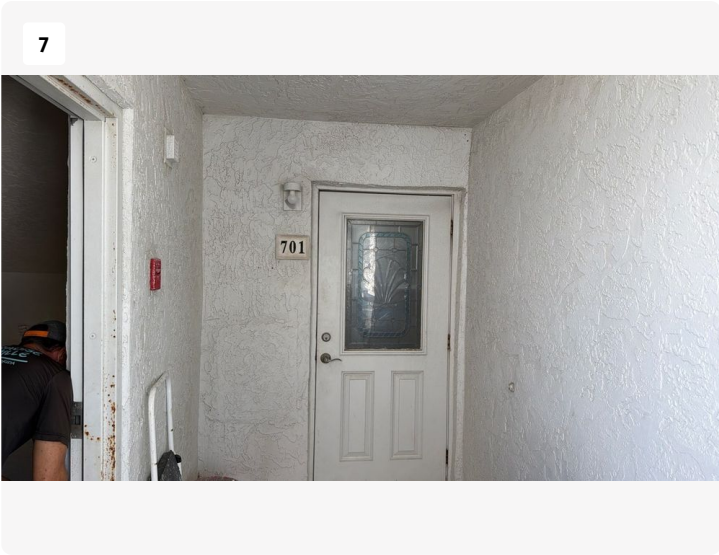
Unit 701

Areas directly adjacent to 701, and directly above the kitchen area of 602 were observed to not have any caulking or waterproofing present on the walkway.

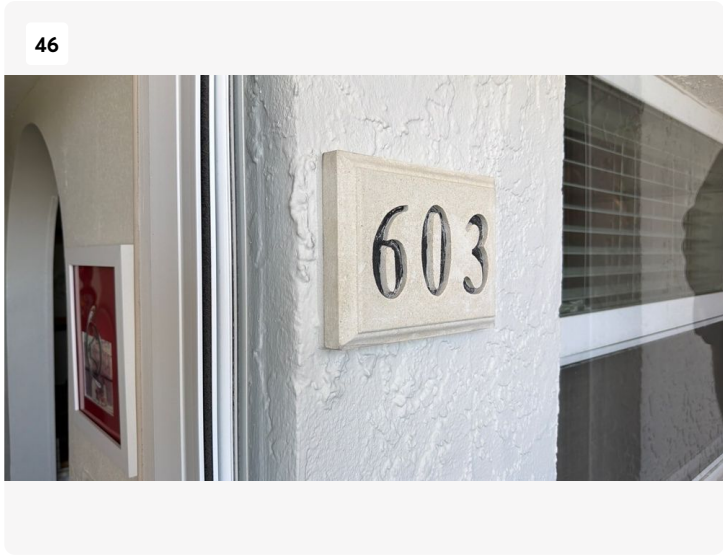
Unit 603

The location of the staining was found to align with the area of concentrated staining in the base of the wall of Unit 701 above. This appeared to have been caused by the leak through the sliding glass door assembly of the unit.

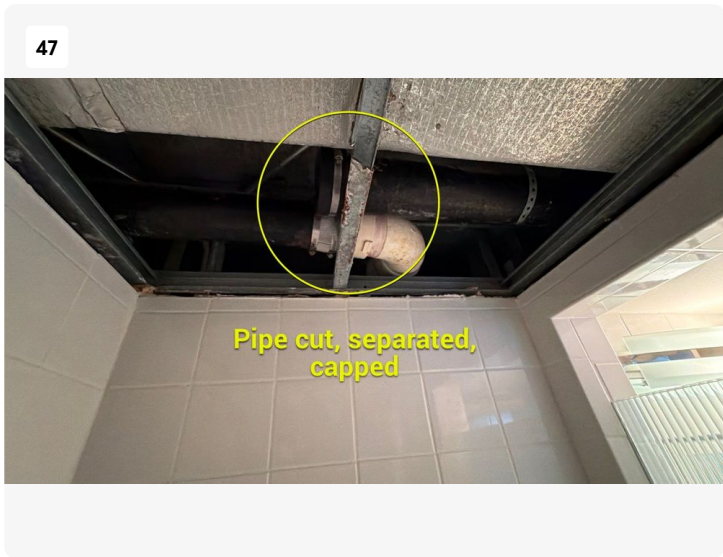
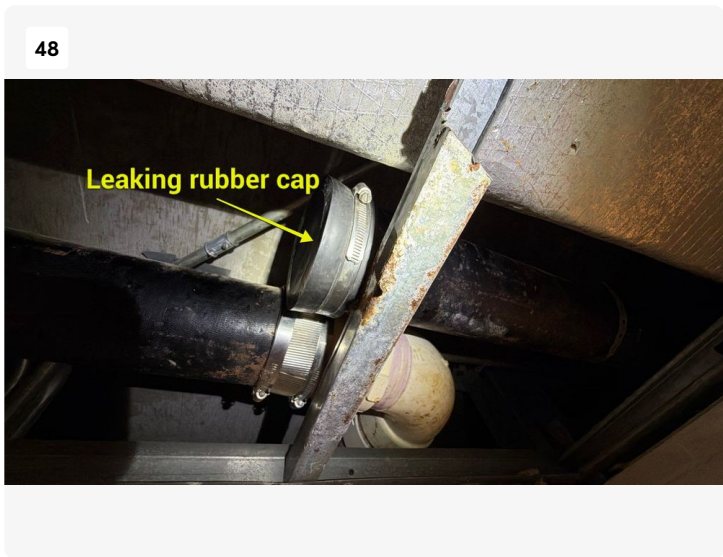
The drain line was observed to be continuous towards the underside of Unit 704.
